Barmouth Beach Blown Sand Management Options

**Report prepared for
Gwynedd Council**

KPAL Report No: 19100

27 October 2016

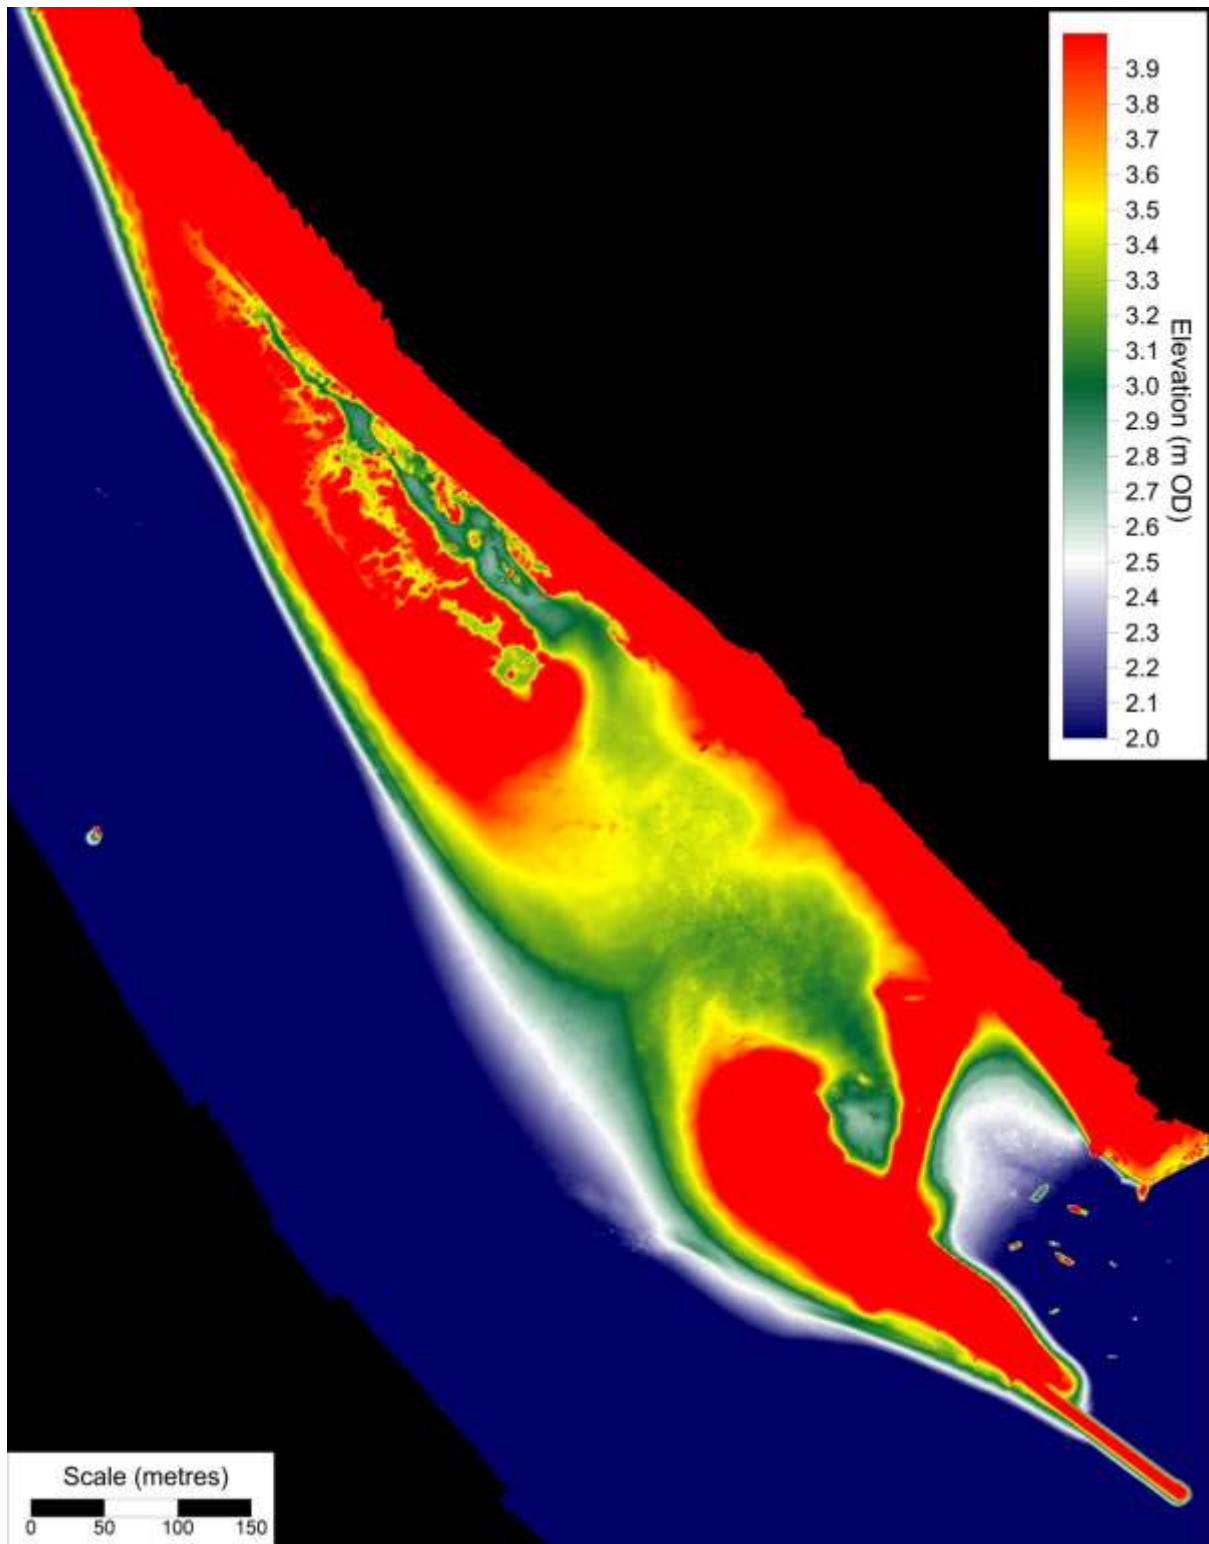
Figure 39. Digital elevation model generated from UAV survey on 16/06/2016, with exaggerated vertical scale to show the channel which has developed on the beach in front of the Lifeboat Station.

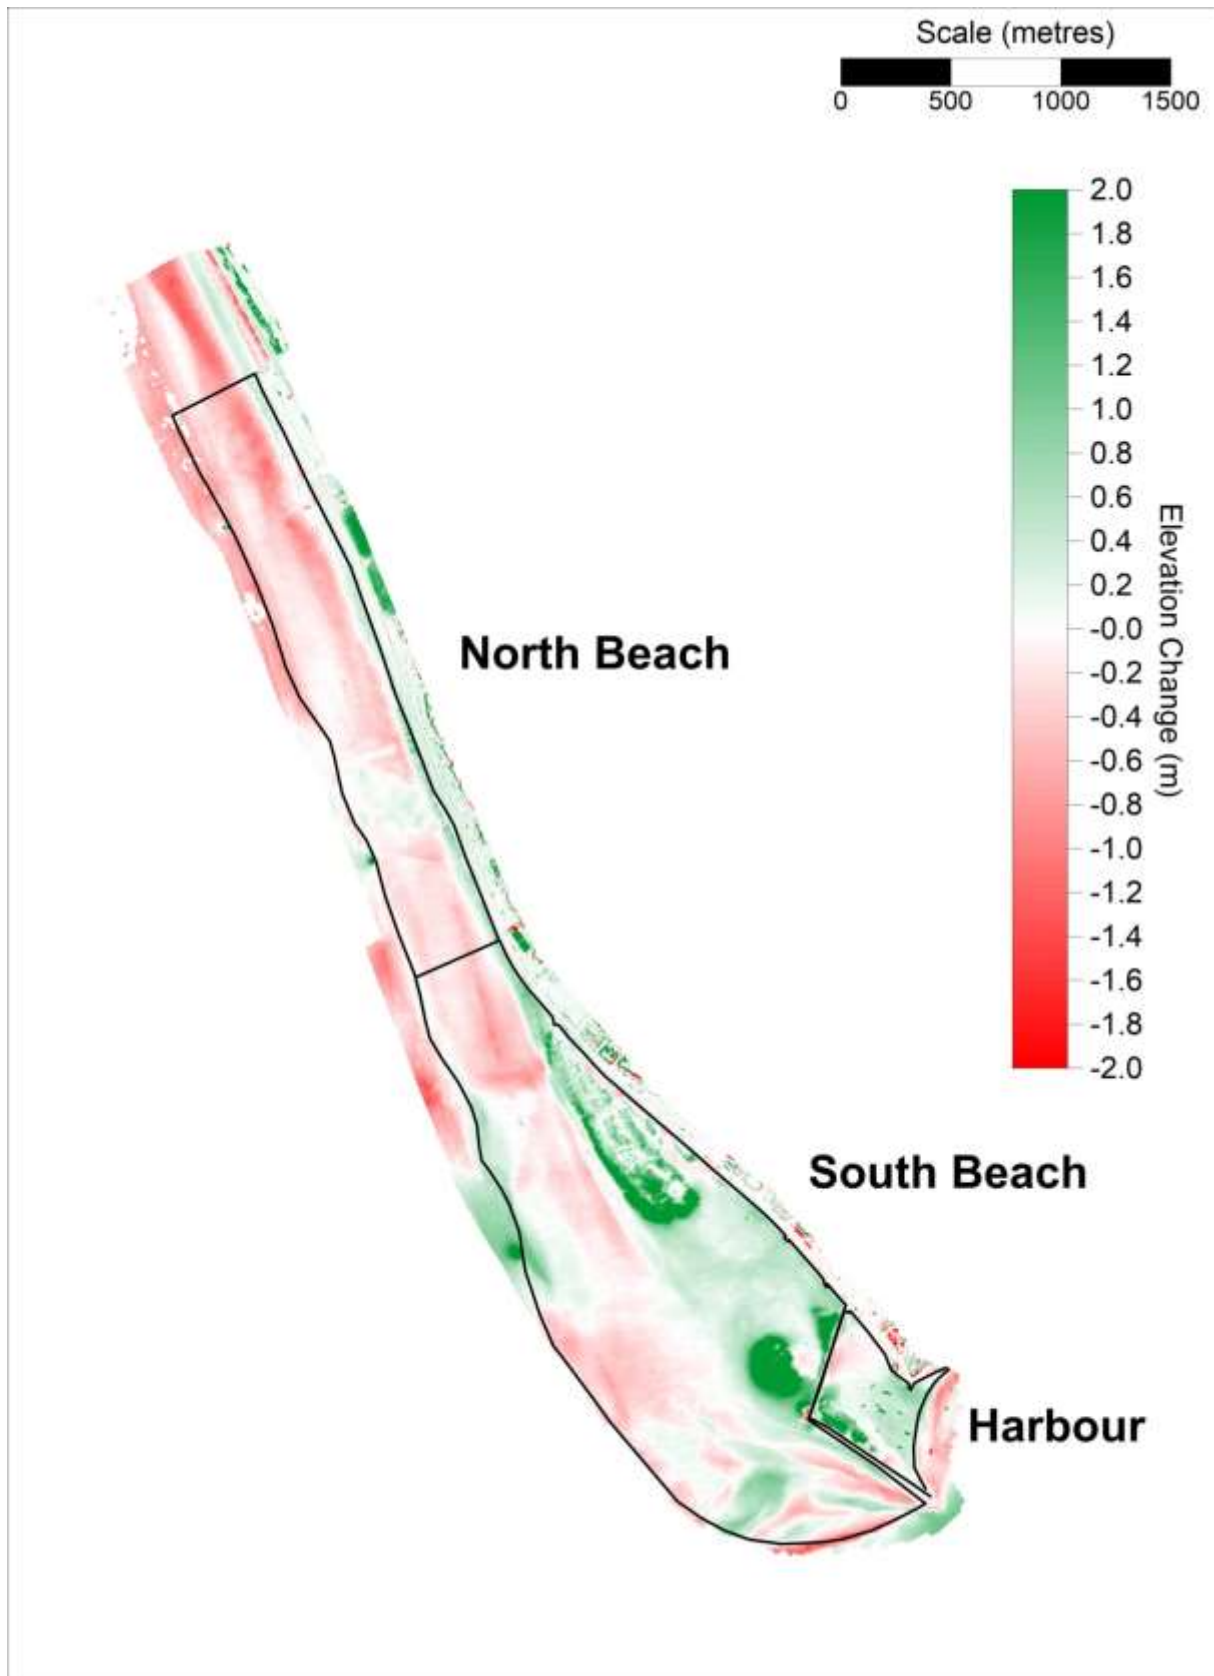
Figure 40. Change in elevation between 14/02/2003 and 16/06/2016, calculated from the difference between digital elevation models generated from the 2003 LiDAR and 2016 UAV surveys. The areas of volume calculations are highlighted by black lines.

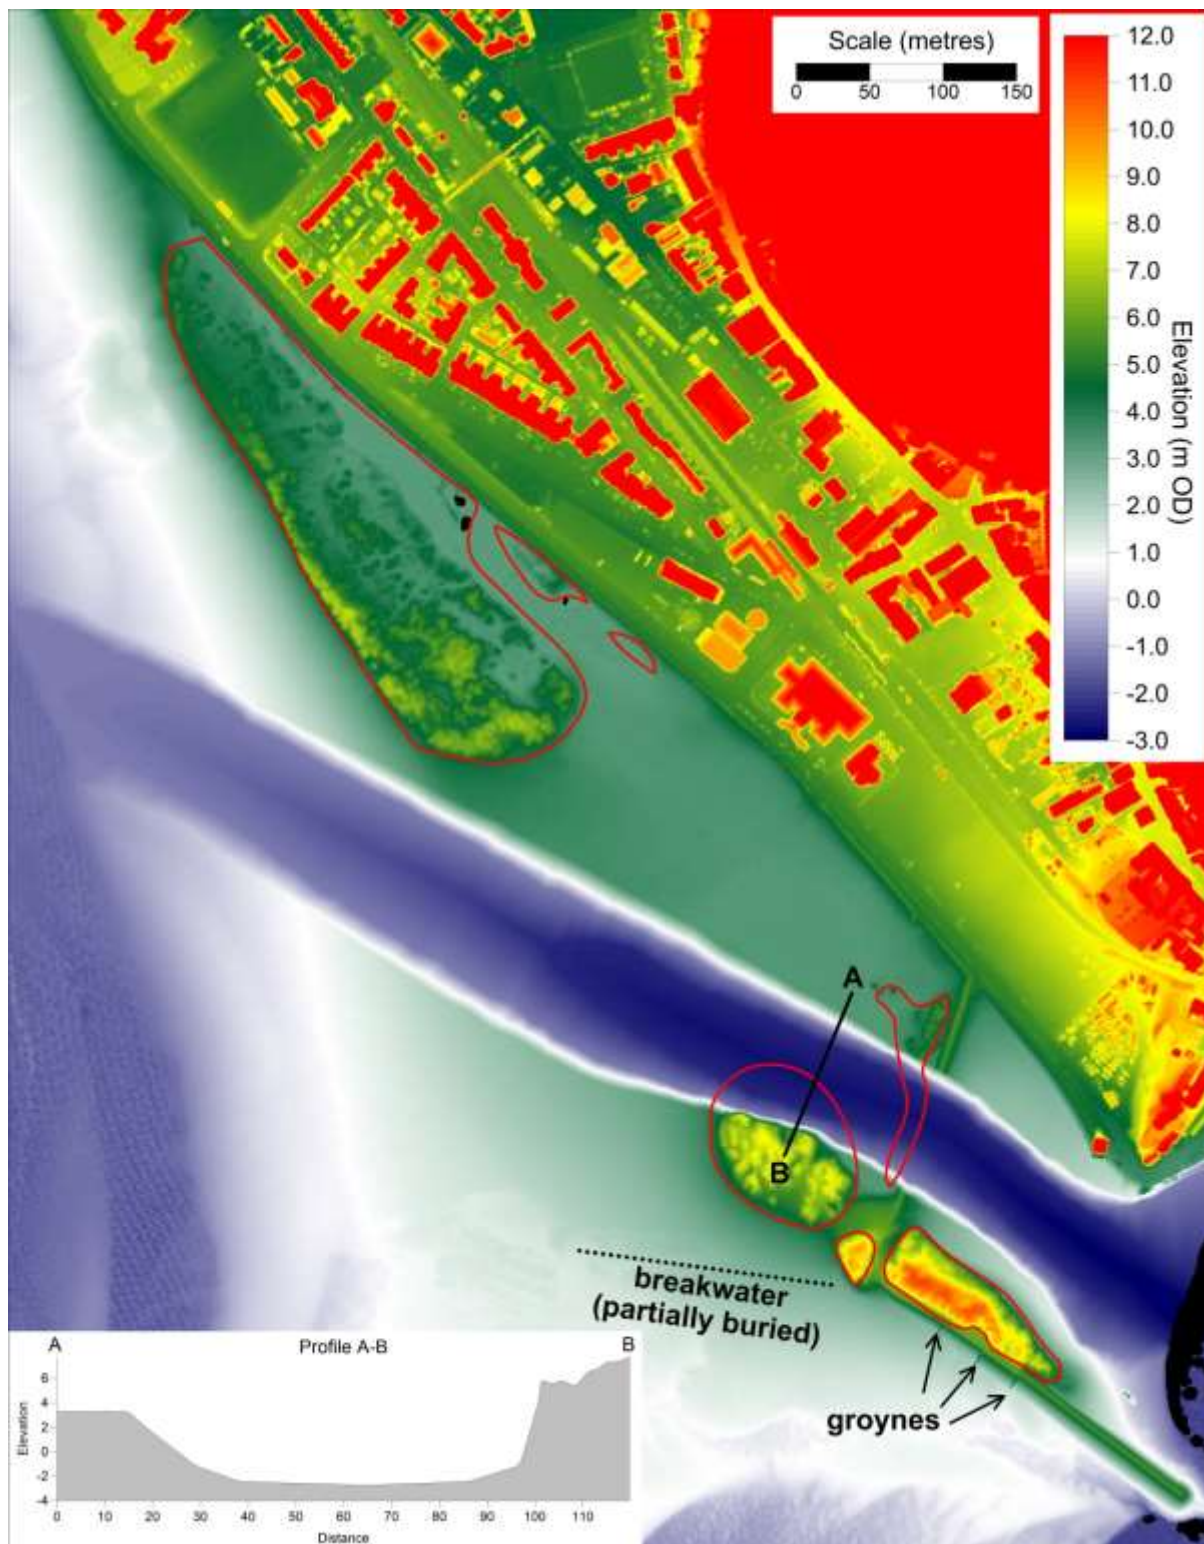
Figure 46. Option A: Reinstatement of the Bar Bach channel. The dimensions are taken from Admiralty survey of 1964, and low water mark from 1971 air photograph. The volume difference, compared to the 2016 UAV survey, is $307 \times 10^3 \text{ m}^3$ of sediment ($\pm 7 \times 10^3$ if allowing for a 10 cm error in the UAV survey).

In order to further assess the volume of sediment which would need to be excavated to reinstate the Bar Bach Channel to its condition in the 1960s, before the causeway was built, the DEM based on the 2016 UAV survey was modified to include depths taken from the 1964 Admiralty survey and the position of the low water mark indicated on aerial photographs (Figure 46). The volume required to restore this topographic configuration is calculated to be $307 \pm 7 \times 10^3 \text{ m}^3$, a figure broadly similar to the previous Gwynedd Council estimate. Most of the material removed would be sand, although there would be some rubble and concrete arising from removal of the causeway (which could be removed in its entirety or in part). Potentially, the excavated sand could be transported northwards to recharge the beach beyond the Min y Mor hotel, thereby improving the coast protection value of the beaches in that area. However, movement of this quantity of material this would require 12000-17,000 lorry or

As a modification to this option, the former channel could be partially reinstated with a shallower depth, in which case the volume of sediment required to be removed could be of the order of $100 - 200 \times 10^3 \text{ m}^3$. While the risk of drownings might thereby be reduced, strandings on Ynys y Brawd would still be likely. Small craft moorings and beachings near the Bath House Café would still be lost, and there would be greater wave activity in the harbour under northwesterly conditions, and there could be increased risk of coastal flooding.

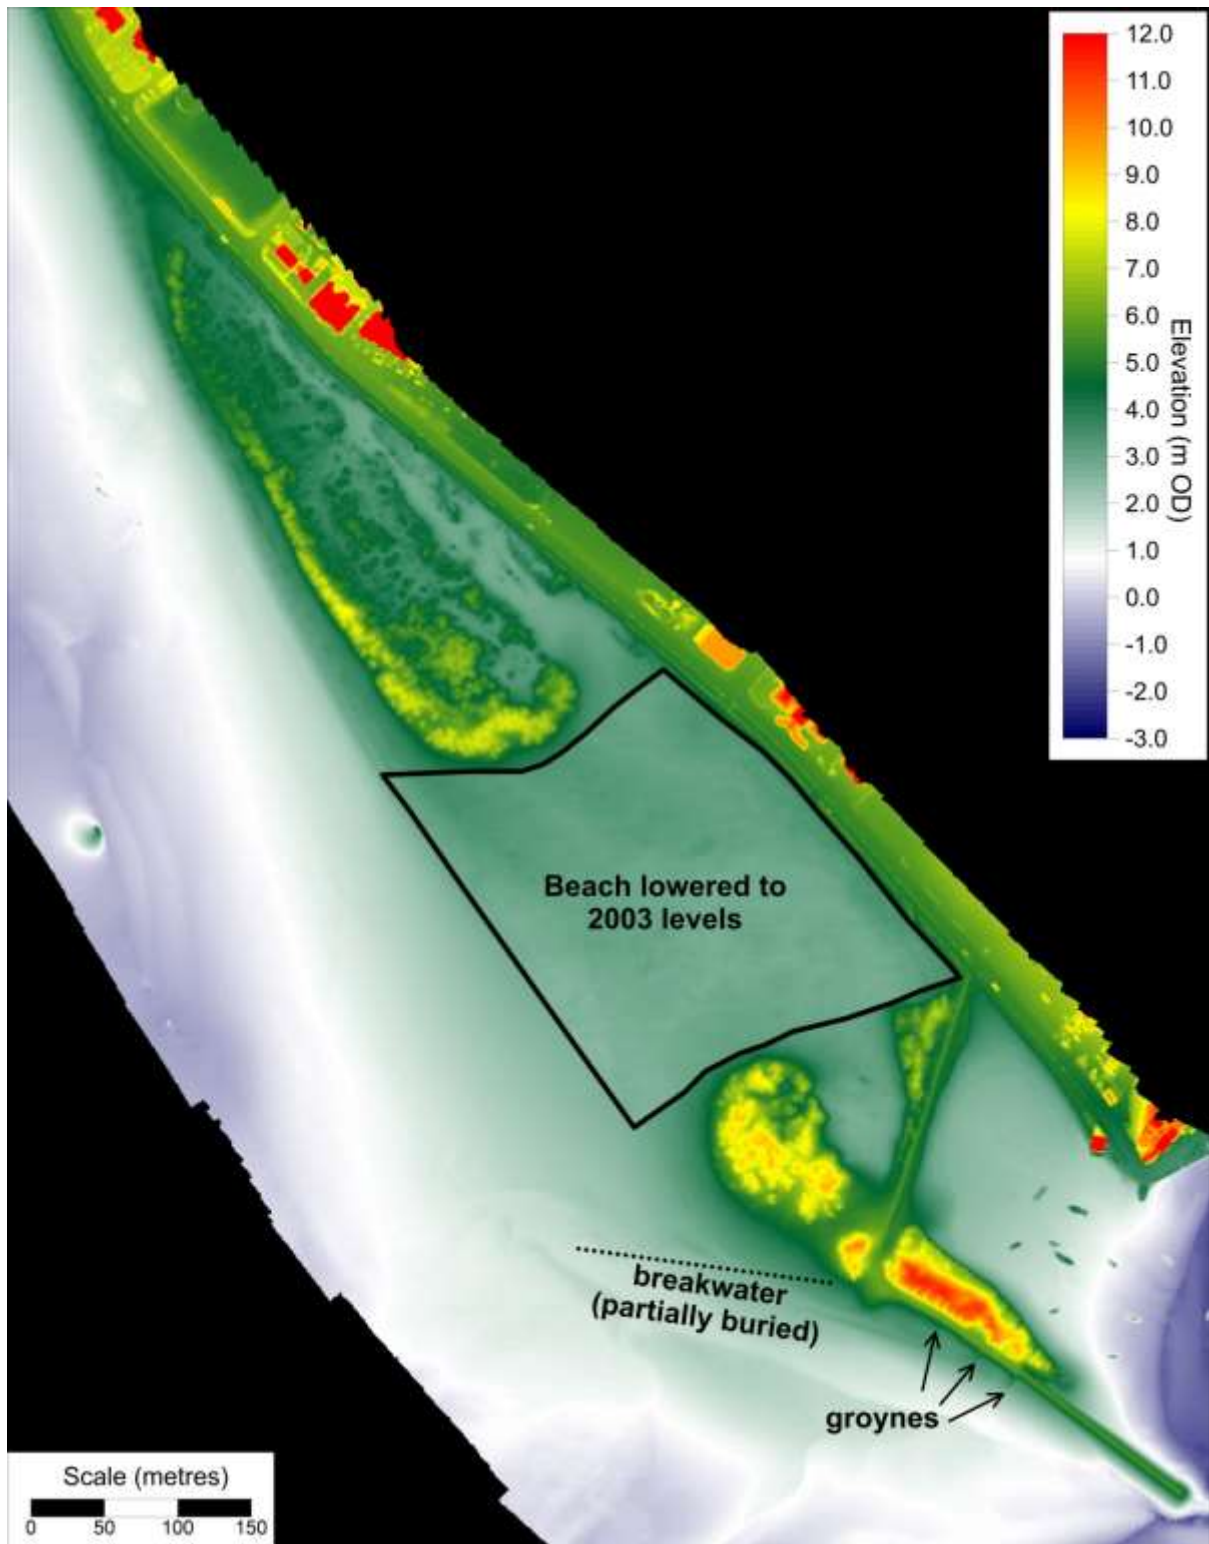
Figure 47. Option B: Lower the main part of the beach between the sand dunes to 2003 levels. The volume difference, between the 2003 LiDAR and the 2016 UAV surveys, is $21 \times 10^3 \text{ m}^3$ of sediment ($\pm 6 \times 10^3$ if allowing for a 10 cm error in the UAV survey). This sediment could be transported to the beach north of this image to replace the losses since 2003

An alternative to reinstating the Bar Bach channel would be to lower a wider area of the open beach and to leave the causeway intact. Figure 47 shows an example where the main part of the open beach between the dunes has been lowered back to 2003 levels. This option, as illustrated, would involve removal of $21 \pm 6 \times 10^3 \text{ m}^3$ of sand which could either be used to create an artificial dune ridge nearby or to nourish the beaches along the northern part of the frontage. This option would achieve a reduction in the height of the dry sand beach of 0.3 to 0.8 m. However, although this would reduce the wind sand transport potential it would not stop it and sand would continue to accumulate against and on top of the promenade during periods of strong northwesterly and westerly winds.

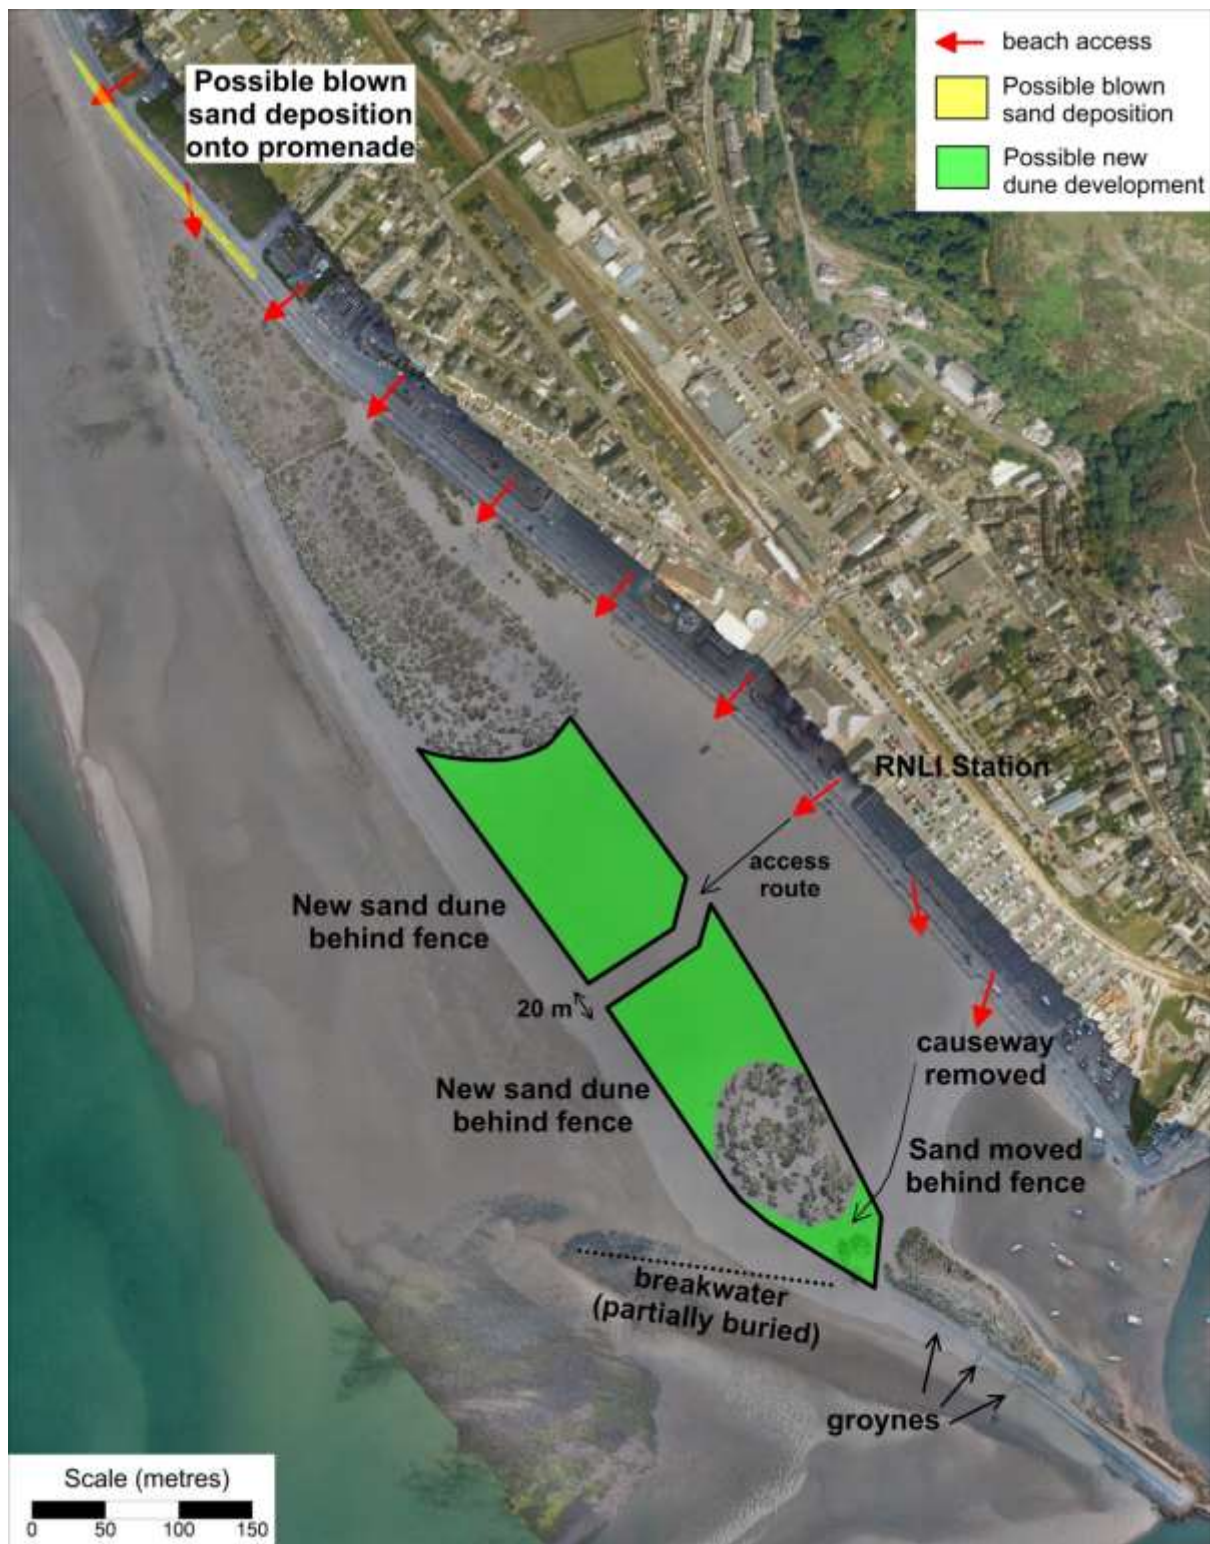
Figure 50. Option E. Extension of the outer line of dunes, half the width of the existing dune belt, removal of the causeway but no reinstatement of Bar-Bach channel, creation of fenced compartments to allow establishment of vegetation (black lines indicate temporary fencing, 550 m in the north, 660 m in the south).

5.2.5 Option E: Extension of a narrow belt of outer dunes with removal of the causeway

This option (Figure 50) combines construction of relatively narrow outer dune extension with removal of the causeway and dunes which have recently developed adjacent to it. This would result in a significant increase in amenity beach area and would allow the eastern end of the former Bar Bach channel (the intertidal part of the harbour opposite the Bath House Café) to evolve in response to natural processes). During surge tides tidal flooding of the entire beach in front of the promenade would be possible from the south, and it is possible that a shallow drainage channel (runnel) would develop in this area after an initial period when sand is likely to be transported towards the harbour by northwesterly winds. Lowering of the beach and development of a runnel linked to the harbour could be encouraged by limited sand excavation.

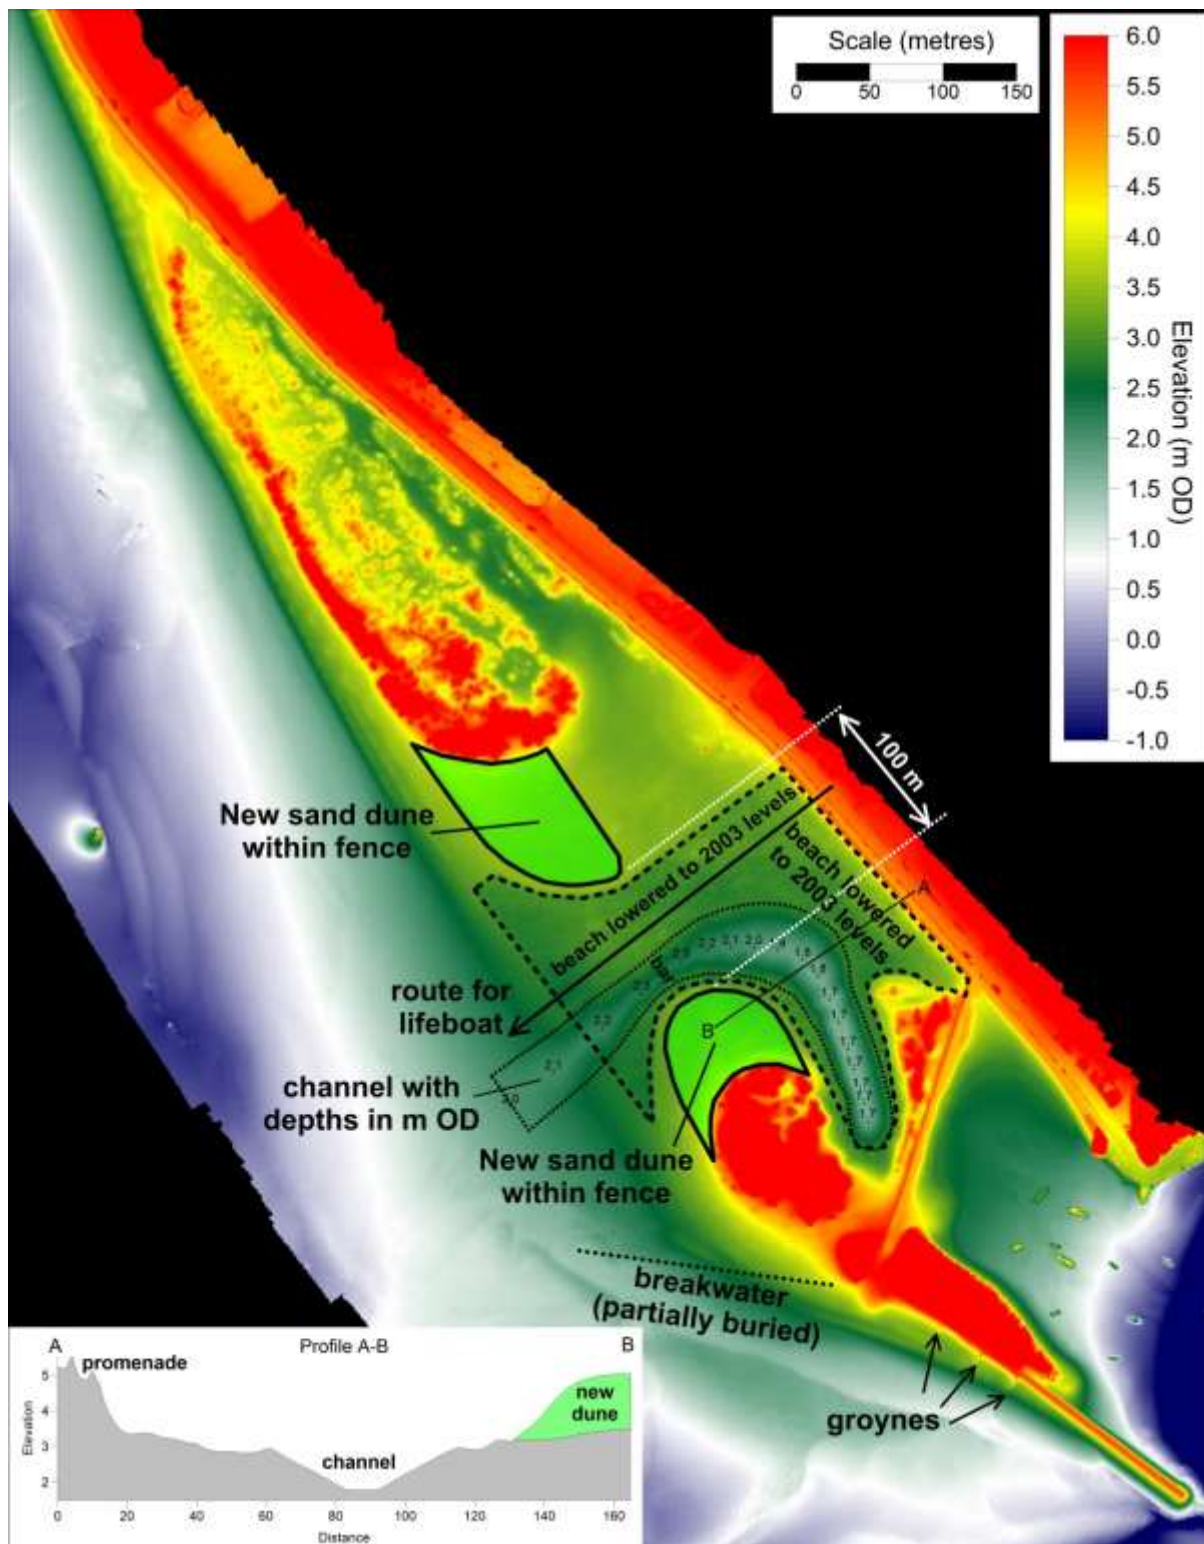
Figure 54. Option I: Lowering the main part of the beach between the sand dunes to 2003 levels, excavation of a shallow channel with a bar at c. 2.3 m OD and ‘lagoon’ with base at 1.7 m OD, expansion of the dune areas on either side using some of the sand from the excavated areas (black lines represent sand fencing, 380 m in the north and 360 m in the south). The total volume of sand to be excavated would be 18110 m³. The area enclosed by fencing to create new dunes is 7130 m² to the north and 5090 m² to the south (12200 m² total). Excavated sand could therefore be added to the new dune areas to an average depth of 1.48 m. The excavated pool would have a maximum depth of 0.86 m on a MHWs high tide and maximum of 0.6 m on a spring low tide (in practice the level would probably drop to 0.4 m to 0.5 m due to seepage through the bar at low tide)

Significant benefits could be achieved at much lower cost from a number of smaller scale options intended to reduce wind speeds and trap sand before it reaches the promenade. However, a composite approach involving lowering of parts of the beach, localised excavation to enlarge and deepen existing natural topographic features of the beach, combined with limited extensions to the existing dune outer dune ridges to provide a more effective wind barrier, could provide the greatest benefits at reasonable cost. It is recommended that further detailed consideration should be given to this option (Option I) in consultation with relevant stakeholders.

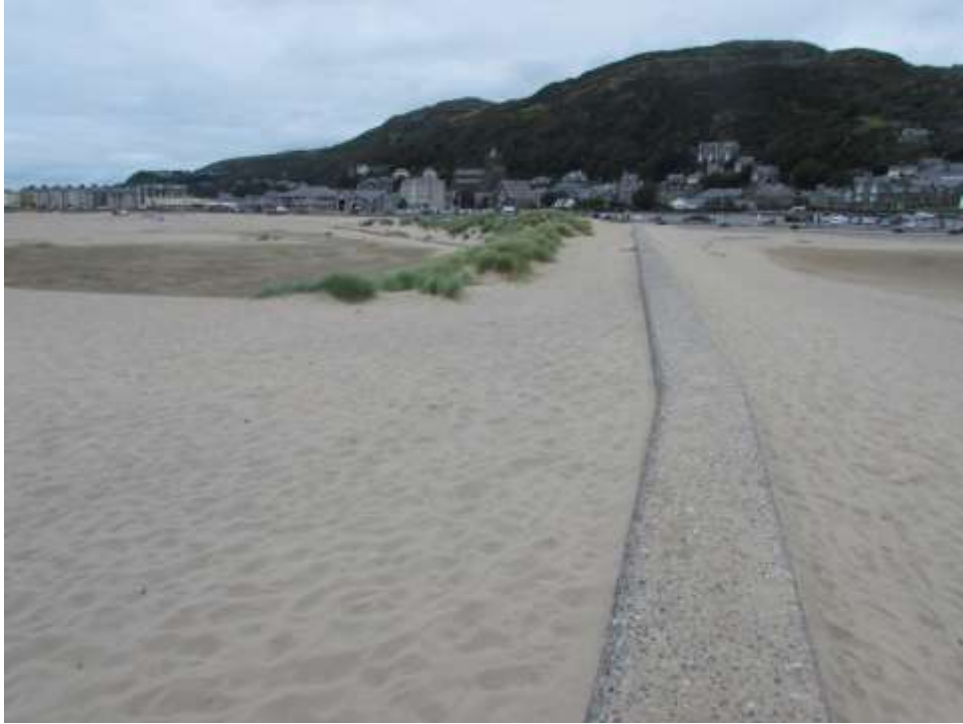
Photograph A1.3. View landwards along the Ynys y Brawd causeway. Only the parapet is visible due to burial of most of the structure by windblown sand

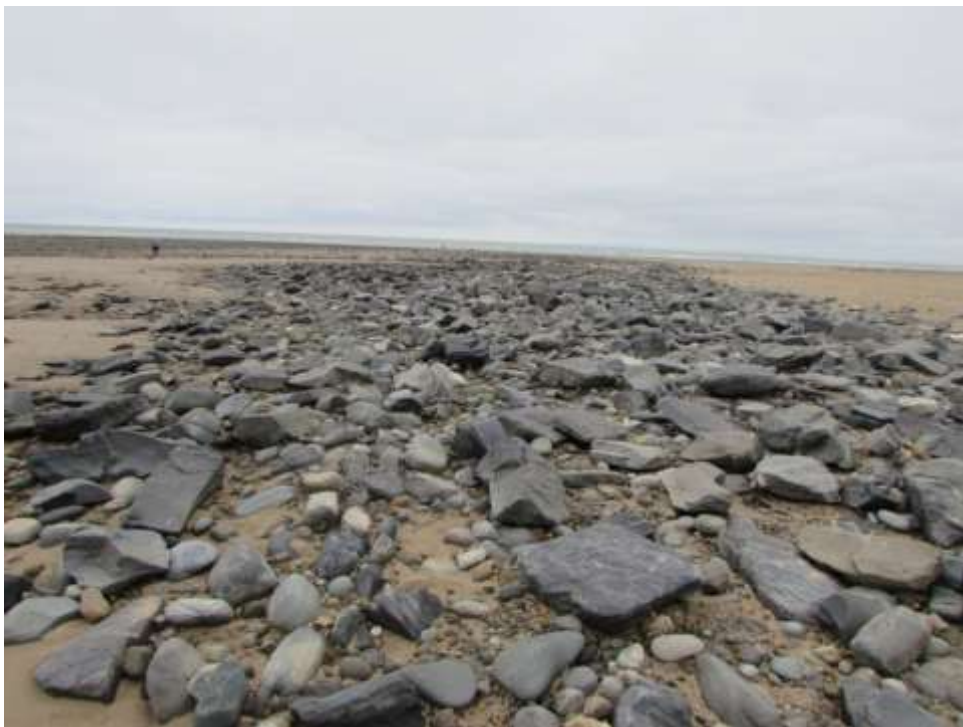
Photograph A1.6. Northern arm of the rubble breakwater exposed on the Ynys y Brawd foreshore

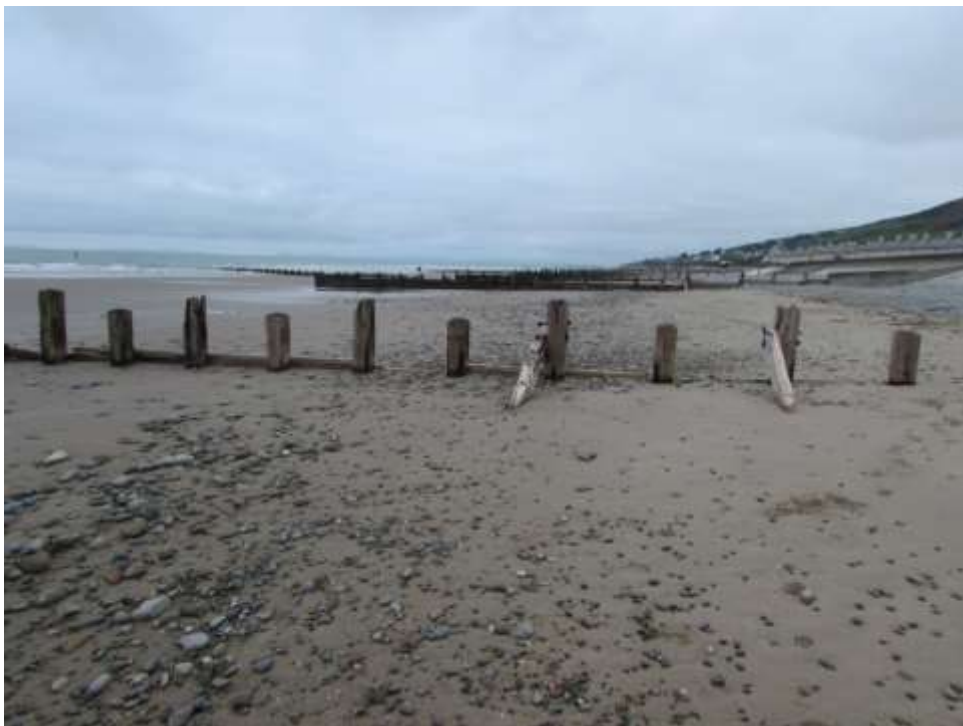
Photograph A1.14. Degraded groynes and low beach to the north of the Min y Mor Hotel

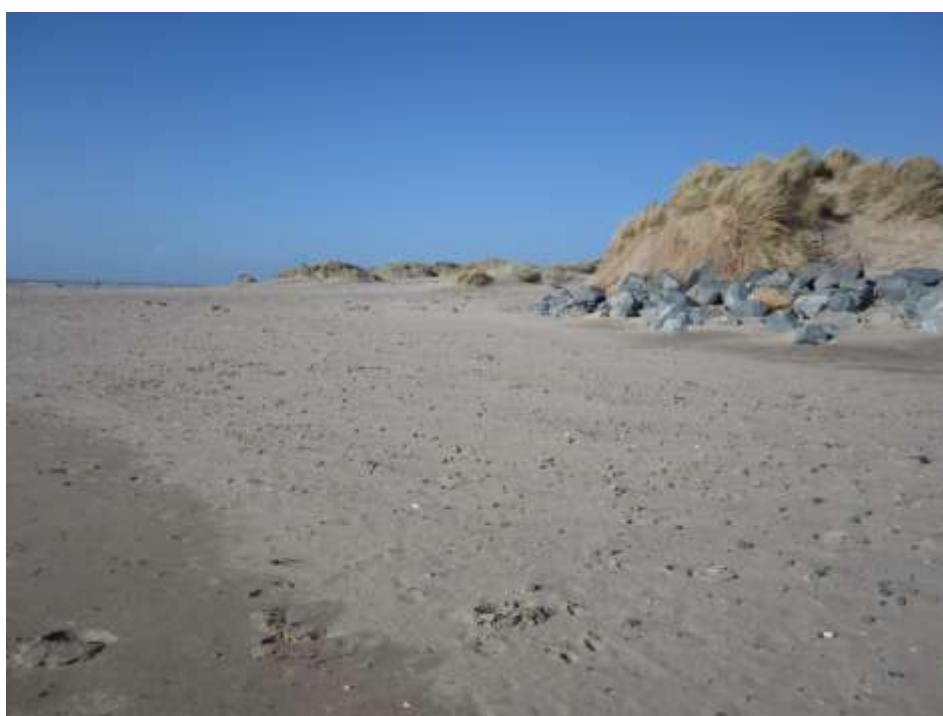
Photograph A2.2. Rock armour at the seaward end of the Ynys y Brawd causeway, exposed by wave erosion of the beach and dunes during the winter storms of December 2013 - February 2014

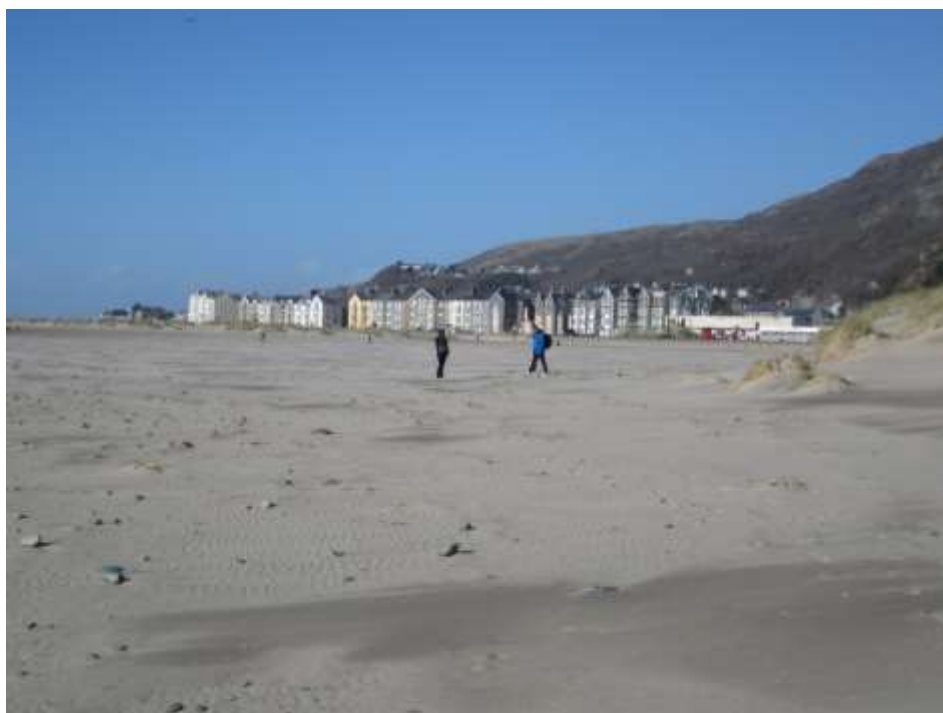
Photograph A2.3. The northern end of the Ynys y Brawd dunes, trimmed by wave erosion during the winter storms of December 2013 - early February 2014, after some re-deposition of windblown sand
