Barmouth Beach Blown Sand Management Options

**Report prepared for
Gwynedd Council**

KPAL Report No: 19100

27 October 2016

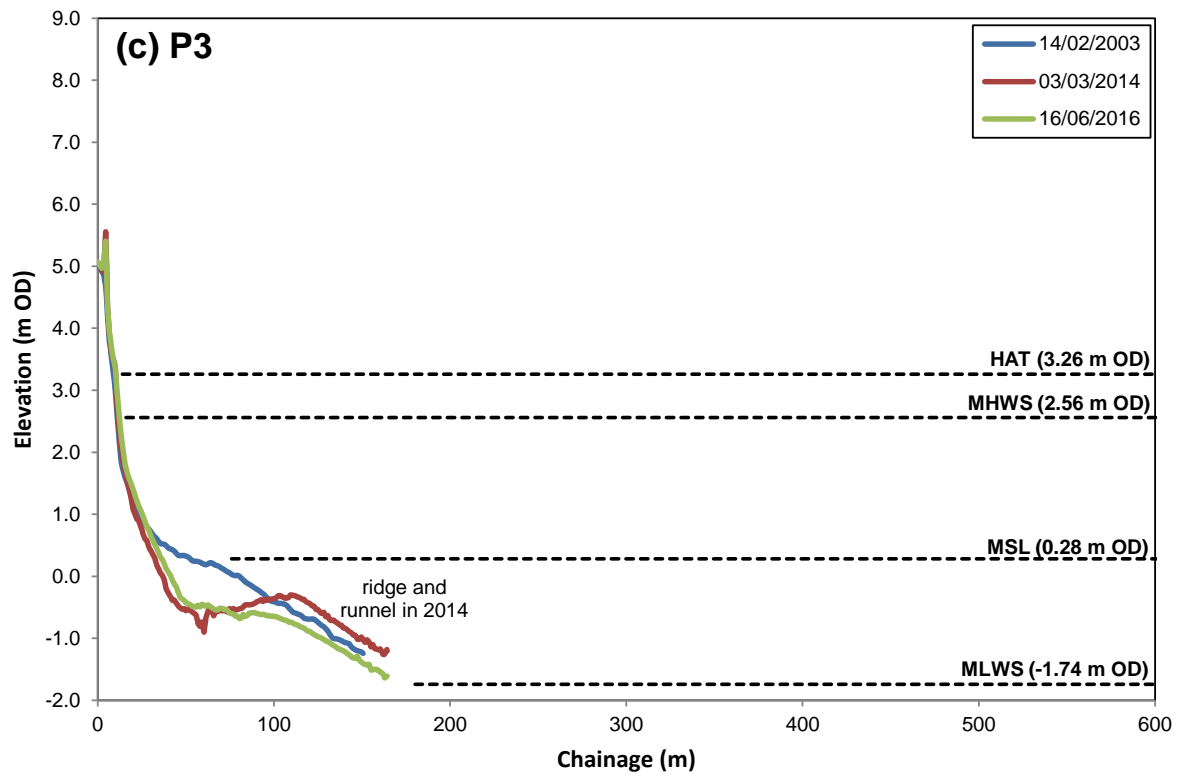
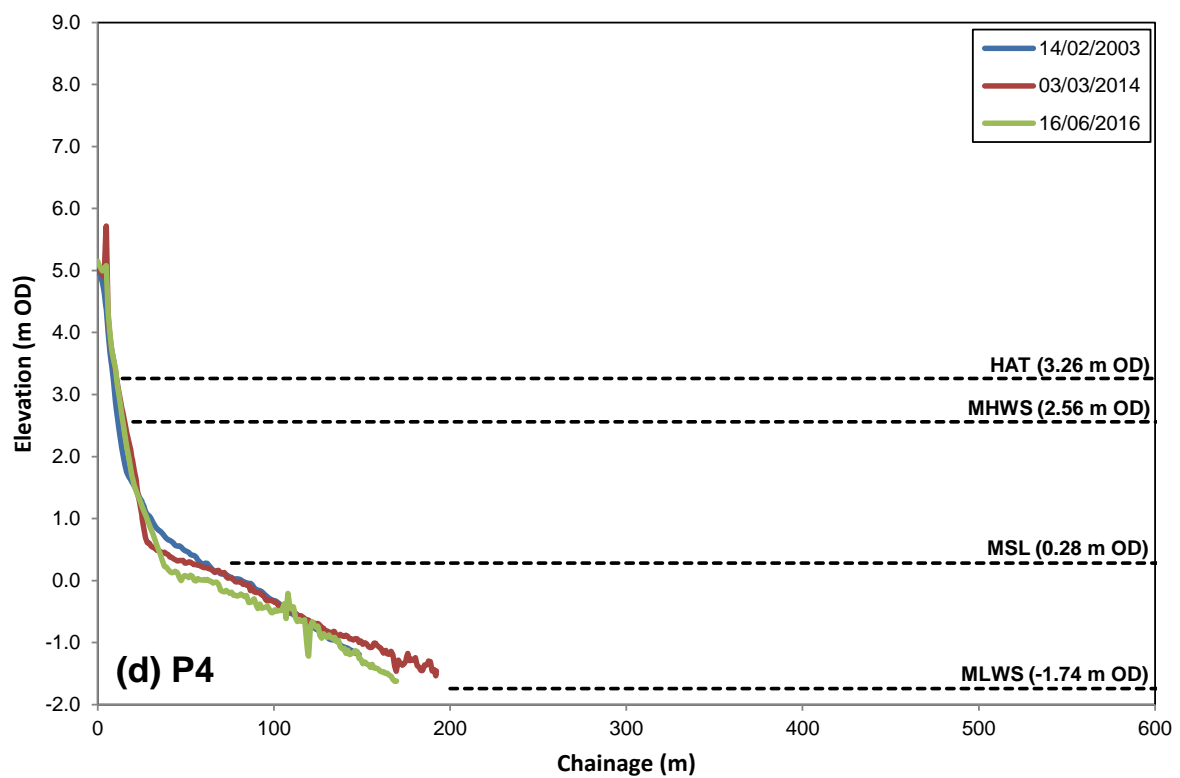
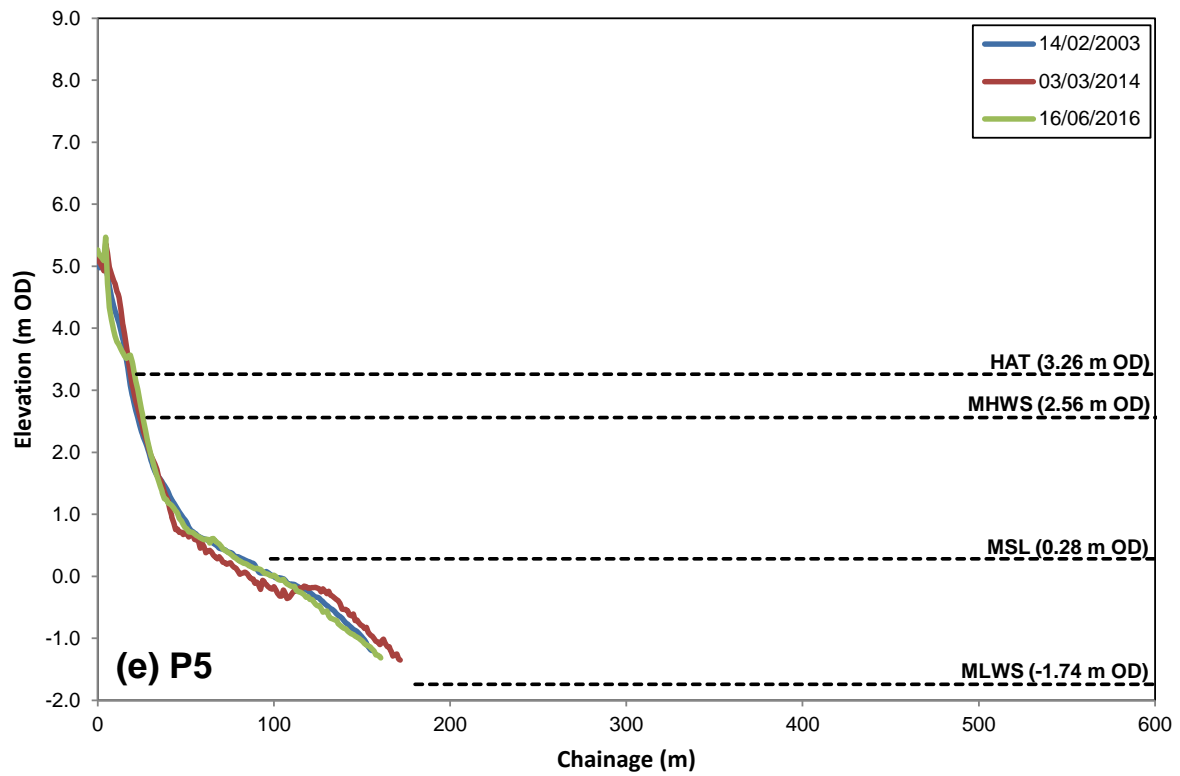
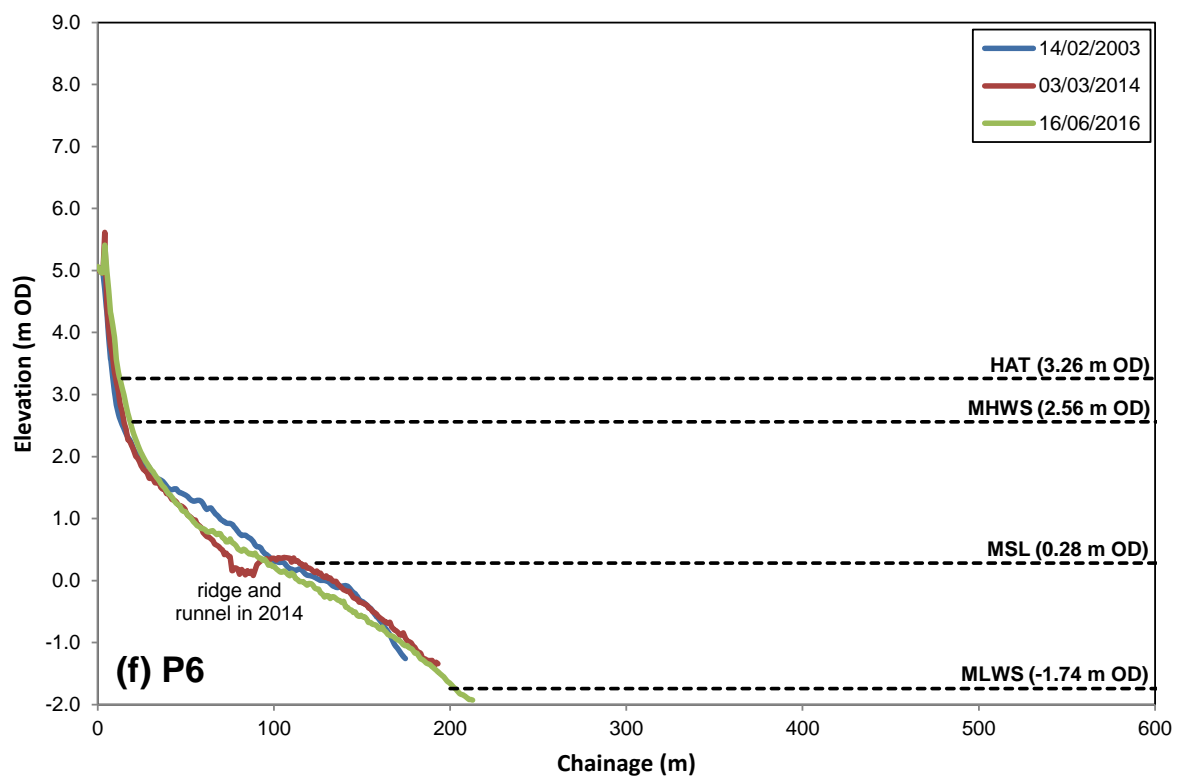
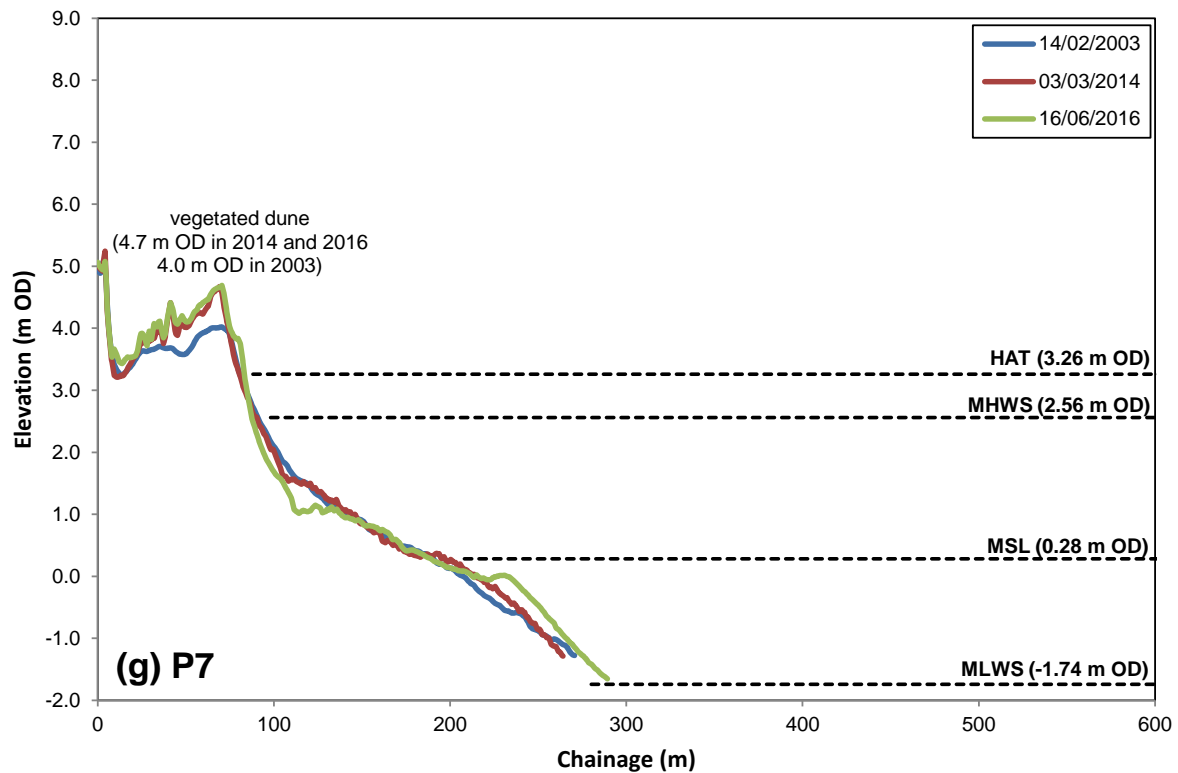
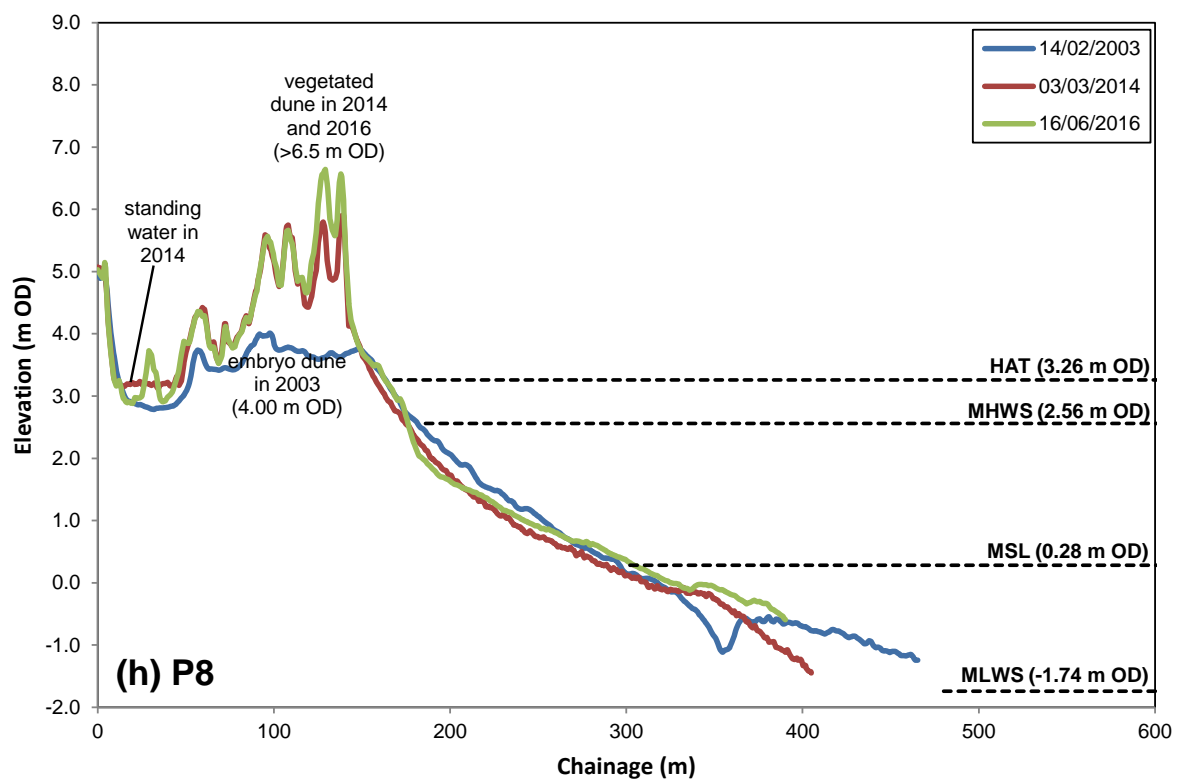
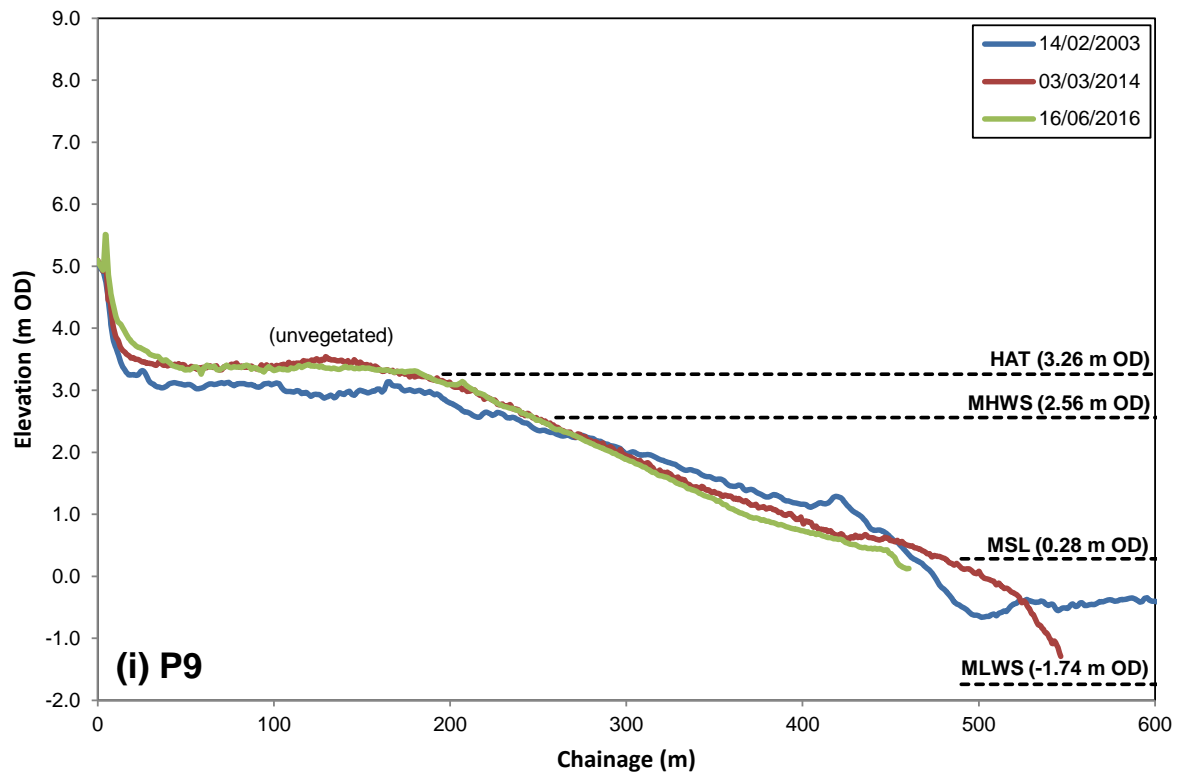
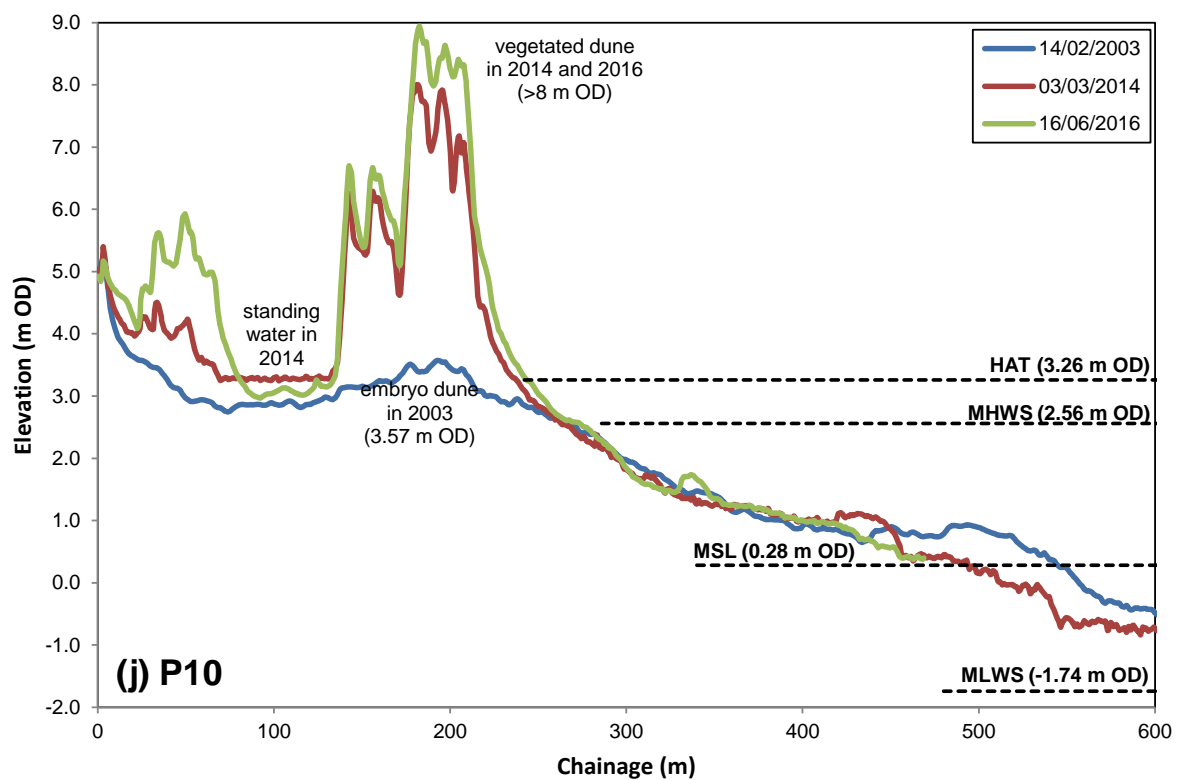
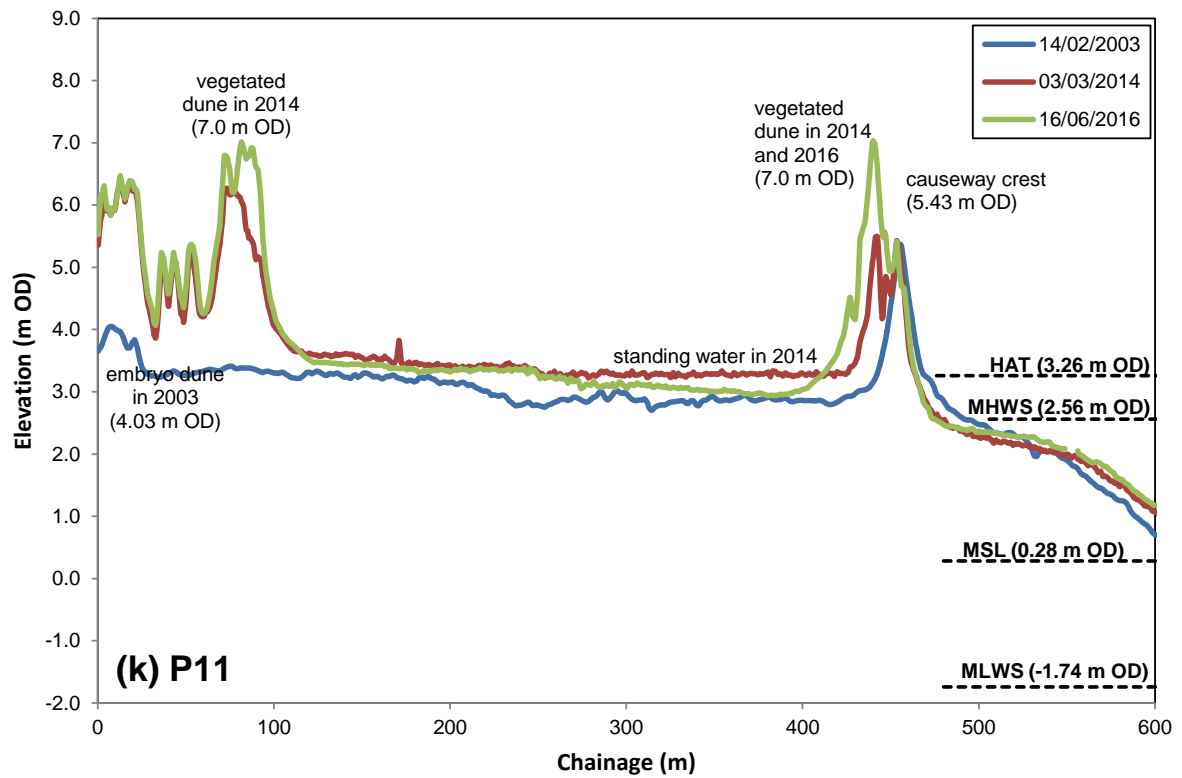
The overall net change in surface elevation between February 2003 and June 2016 is shown in Figure 40. Changes in beach level at the profile lines P1 to P11 are shown in Figure 41, and movements of tidal contours are shown in Figures 42, 43 & 44. The main changes can be summarised as follows:

Figure 41. Cross-sections of the dune and beach at Barmouth, from airborne LiDAR surveys flown on 14/02/2003 and 03/03/2014.

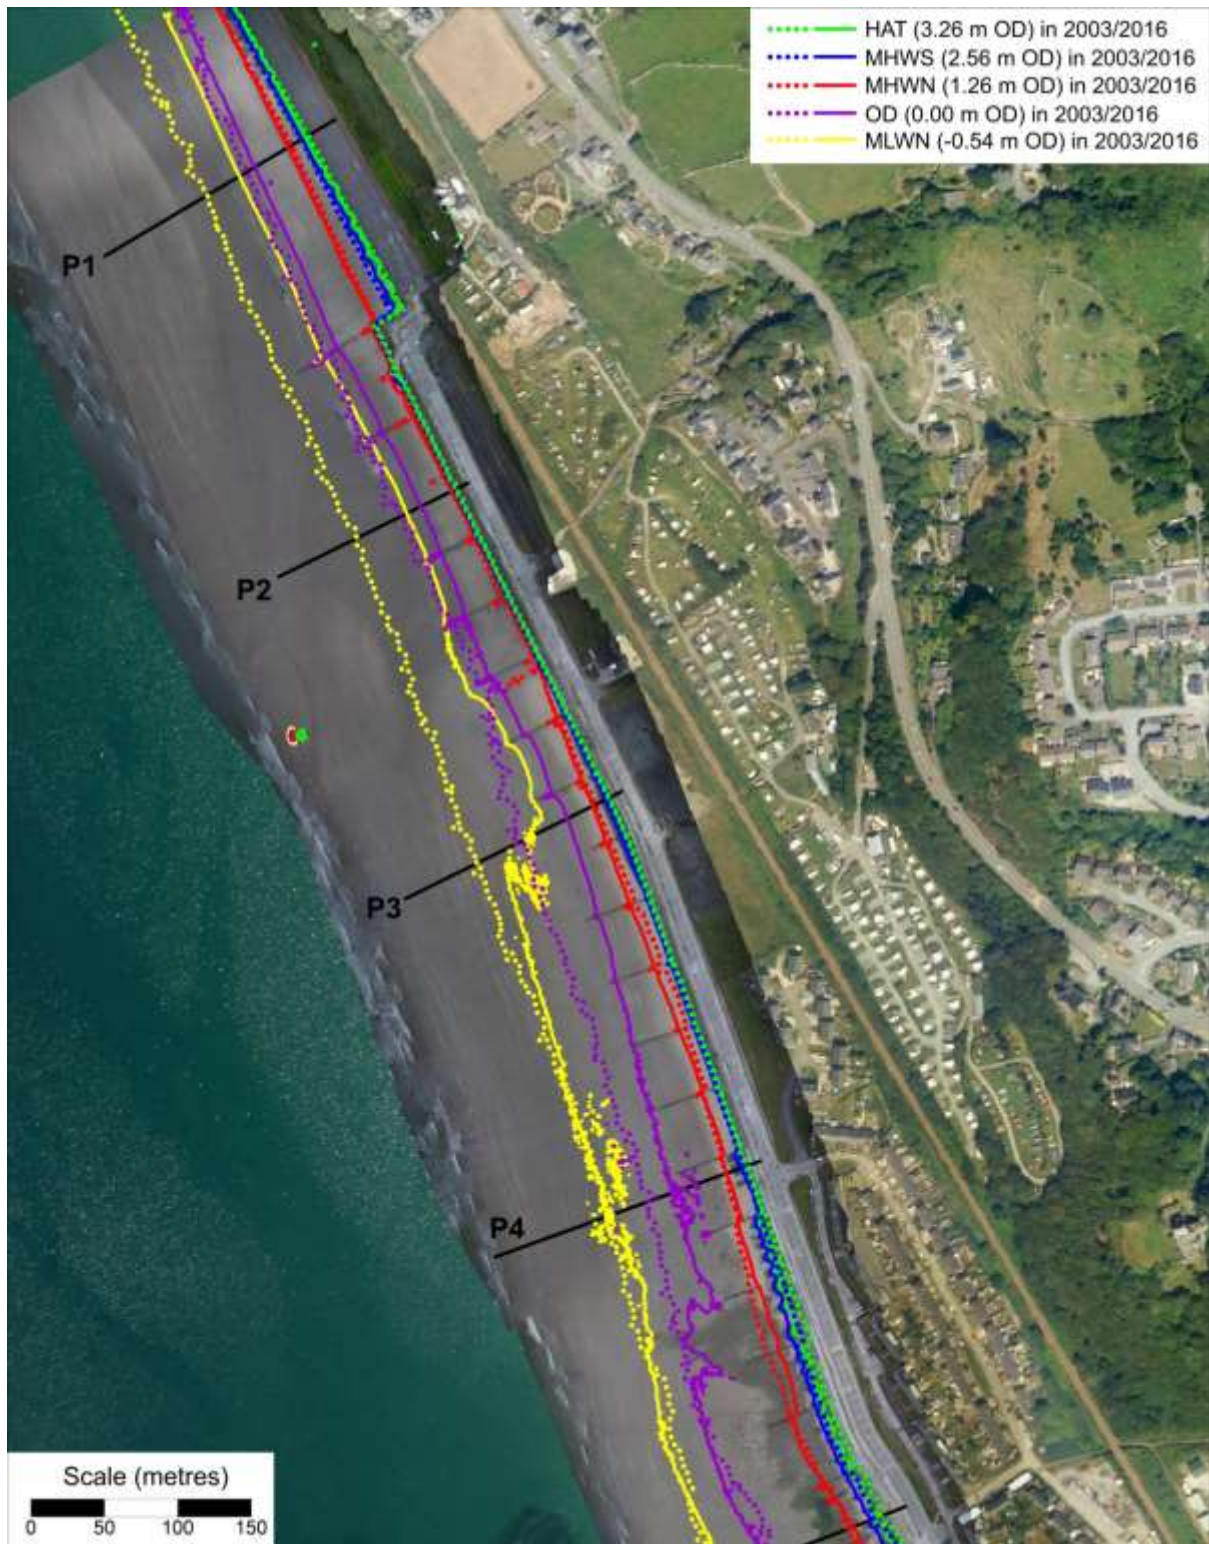
Figure 42. Changes in the position of tidal contours between profiles 1 and 4, from the 2003 LiDAR and the 2016 UAV surveys.

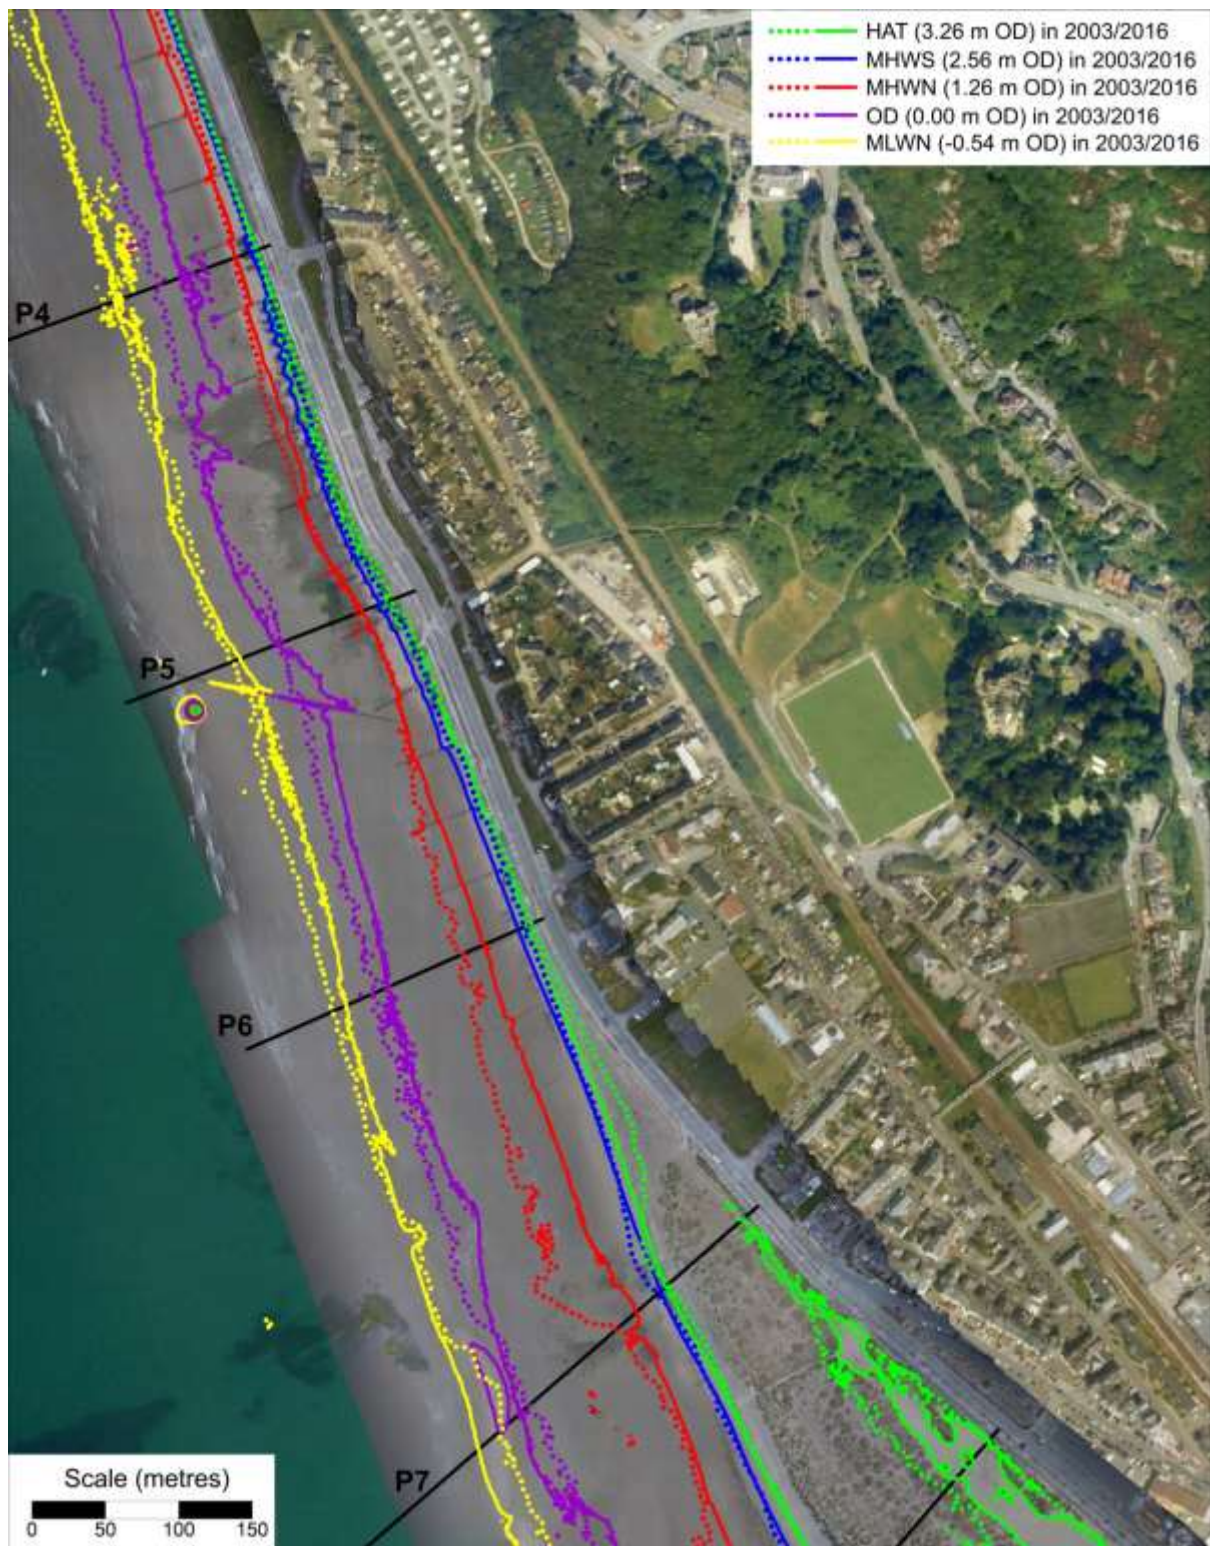
Figure 43. Changes in the position of tidal contours between profiles 4 and 7, from the 2003 LiDAR and the 2016 UAV surveys.

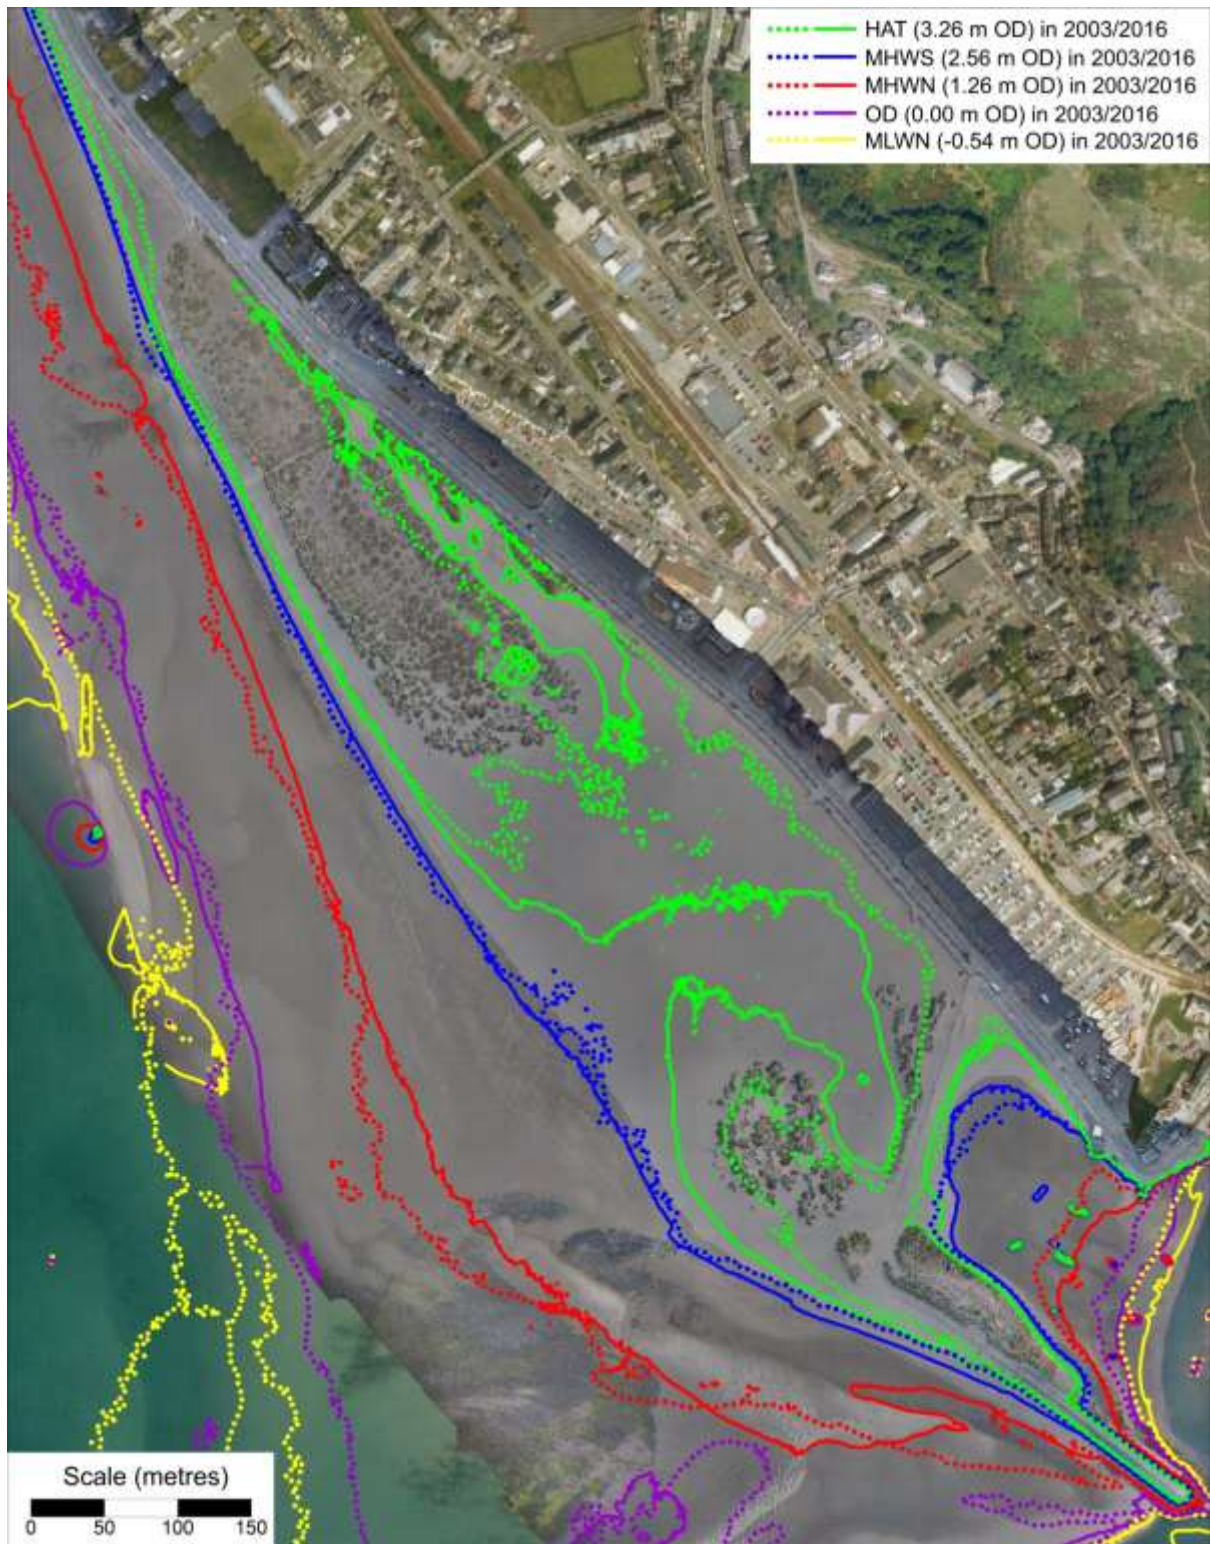
Figure 44. Changes in the position of tidal contours between profiles 7 and 11, from the 2003 LiDAR and the 2016 UAV surveys.

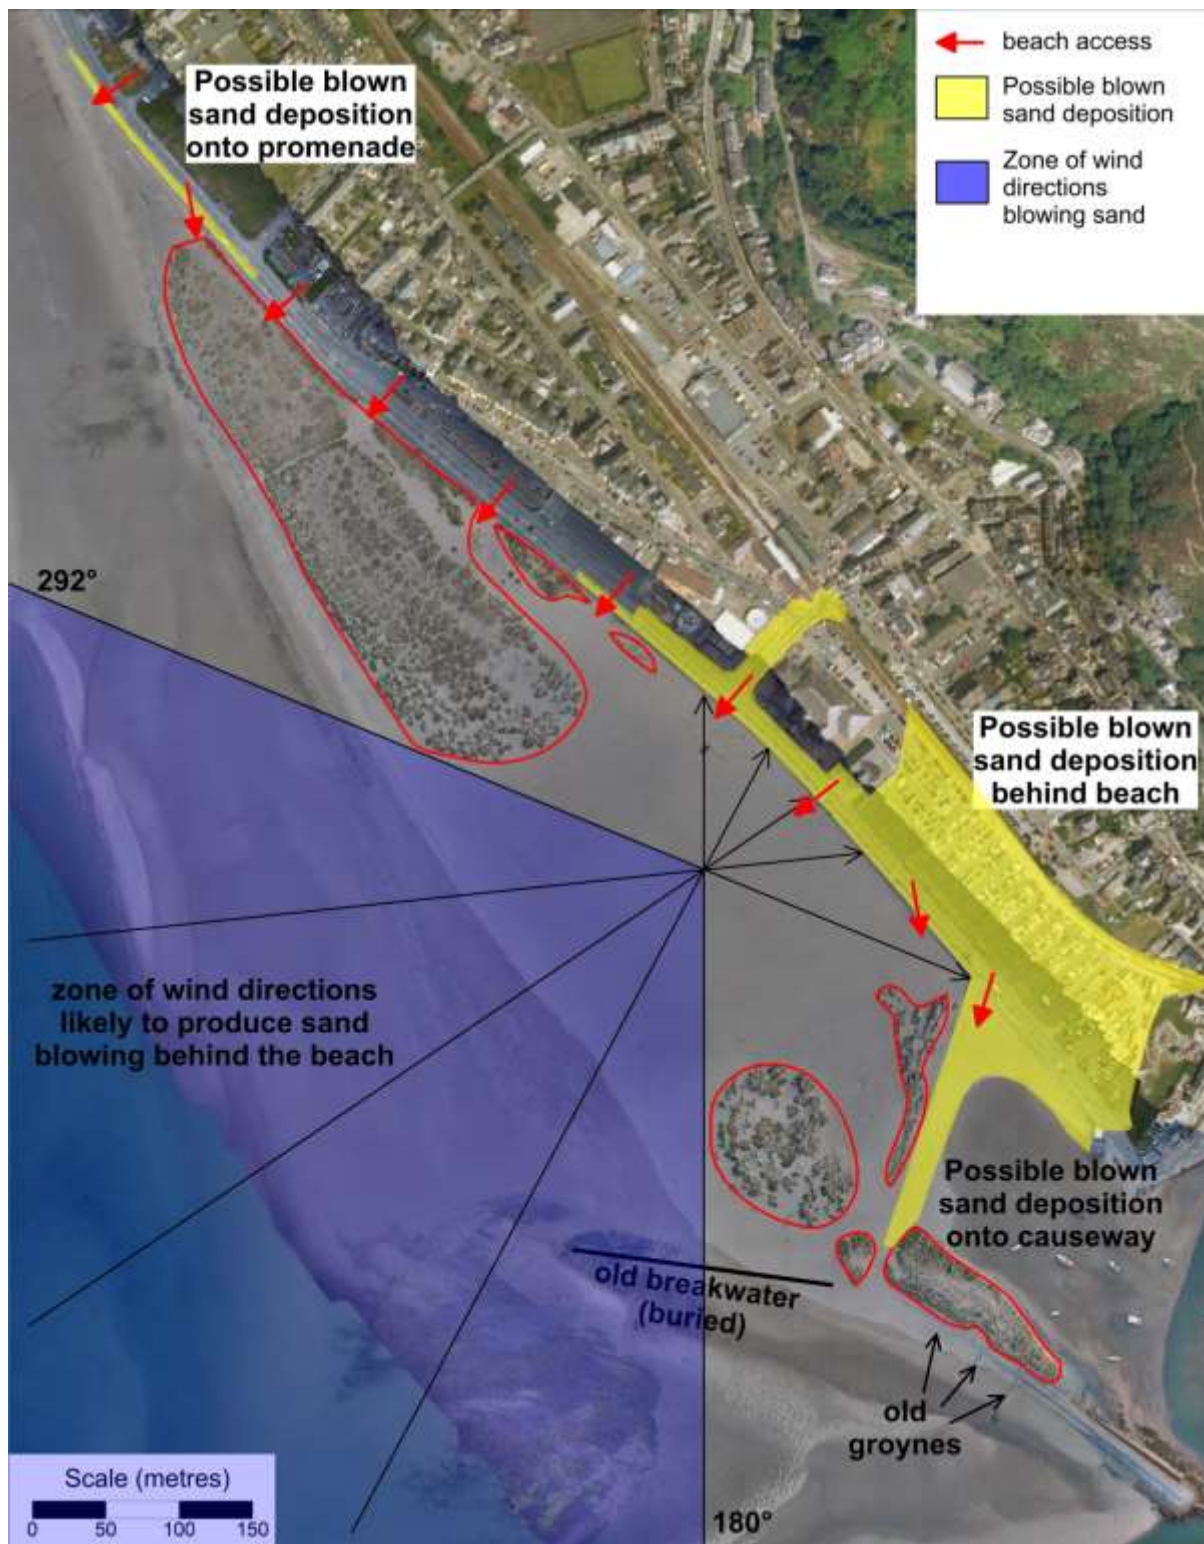
The increase in dry sand beach area above MHWS level after building of the causeway increased the potential source area for windblown sand transport, and also increased the requirement to clear sand from the promenade, car park, sailing club and railway line (Gwynedd Council, 2016). While sand can be mobilised by winds from any direction, incursion onto the southern part of the promenade is most frequently associated with strong winds from the northwest and west which blow across a long fetch unobstructed by dunes (Figure 45). The most severe aeolian transport conditions occur when strong winds occur without rain, and when the tides are relatively low. Extreme high tides cover the upper beach with water and large parts of the beach may remain wet for several weeks during the winter and spring, when temperatures and evaporation rates are relatively low, rainfall more frequent and the beach water table relatively high. As the beach sand is relatively fine and well sorted (typical modal size of 200 - 250 μm), it is easily entrained by the wind when dry and not salt crusted (Pye *et al.*, 2007; Pye & Tsoar, 2009).

Figure 45. The zone of wind directions likely to produce sand blowing behind the beach, between 180° and 292° (south to west-north-west). The red lines indicate the limits of vegetation mapped in 2016 by the UAV survey. Base photo is from the UAV survey on 16 June 2016, with the offshore and areas behind the promenade covered by photos flown in 2013. The yellow area shows the current extent of blown sand risk behind the beach.

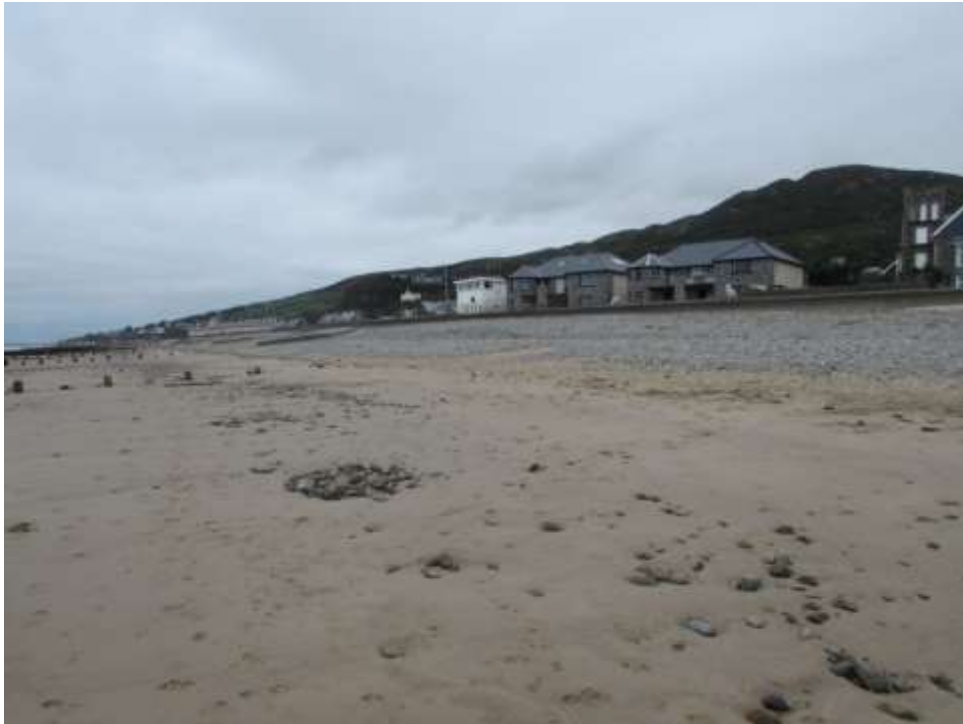
Photograph A1.13. The upper beach near the Min y Mor Hotel which forms a transition zone between net erosion to the north and net accretion to the south

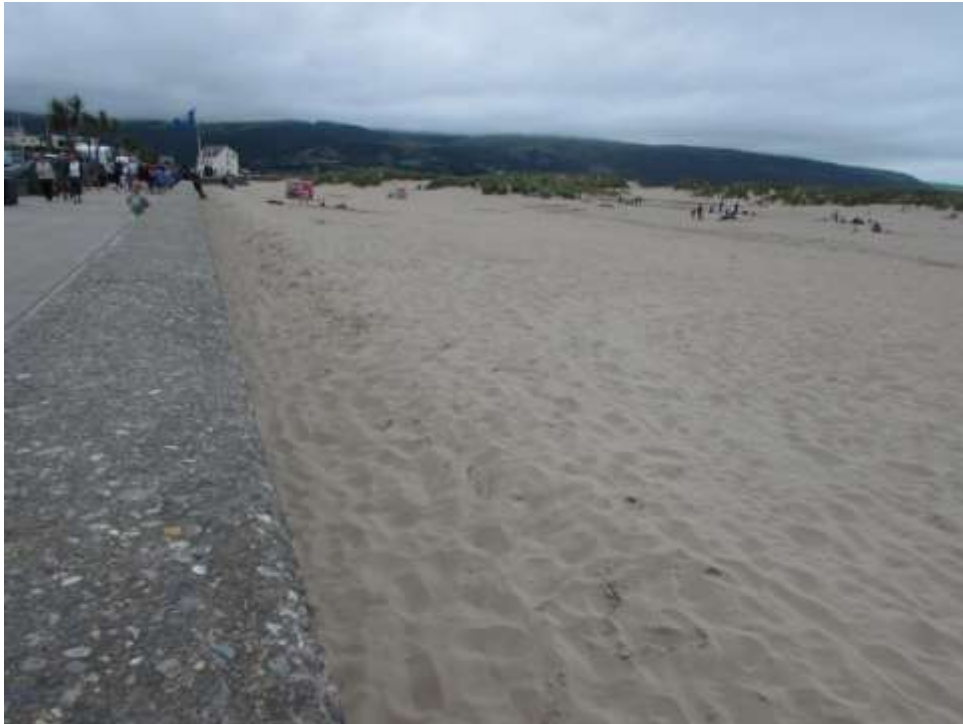
Photograph A1.22. View south along the upper beach adjacent to the south-central part of the promenade where sand has been excavated to create a trough adjacent to the wave return wall

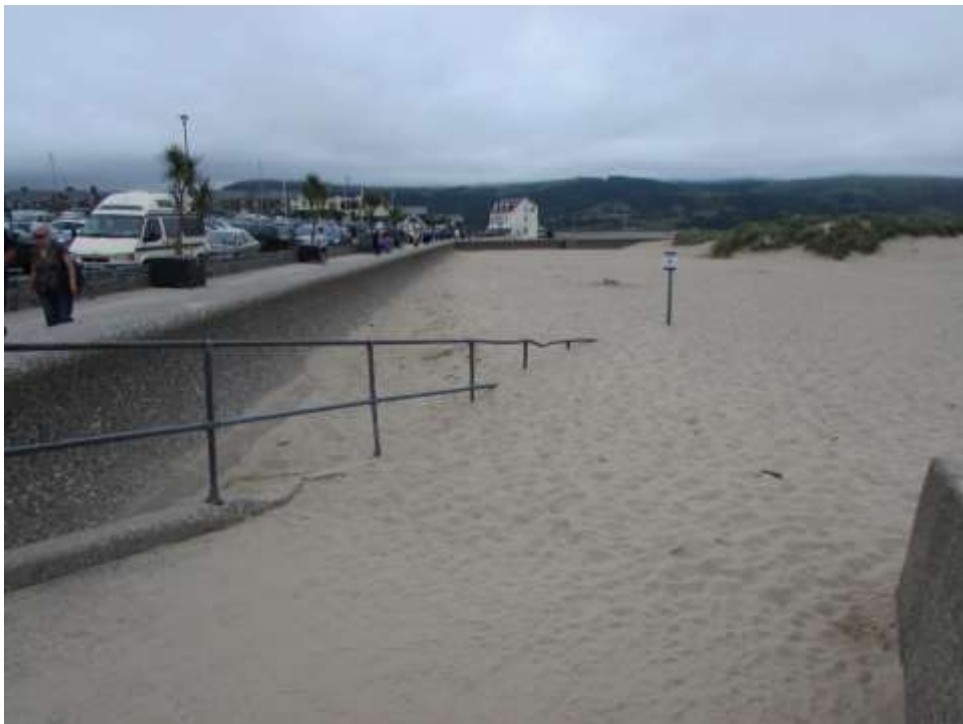
Photograph A1.23. Slipway partially blocked by windblown sand, southern part of the promenade

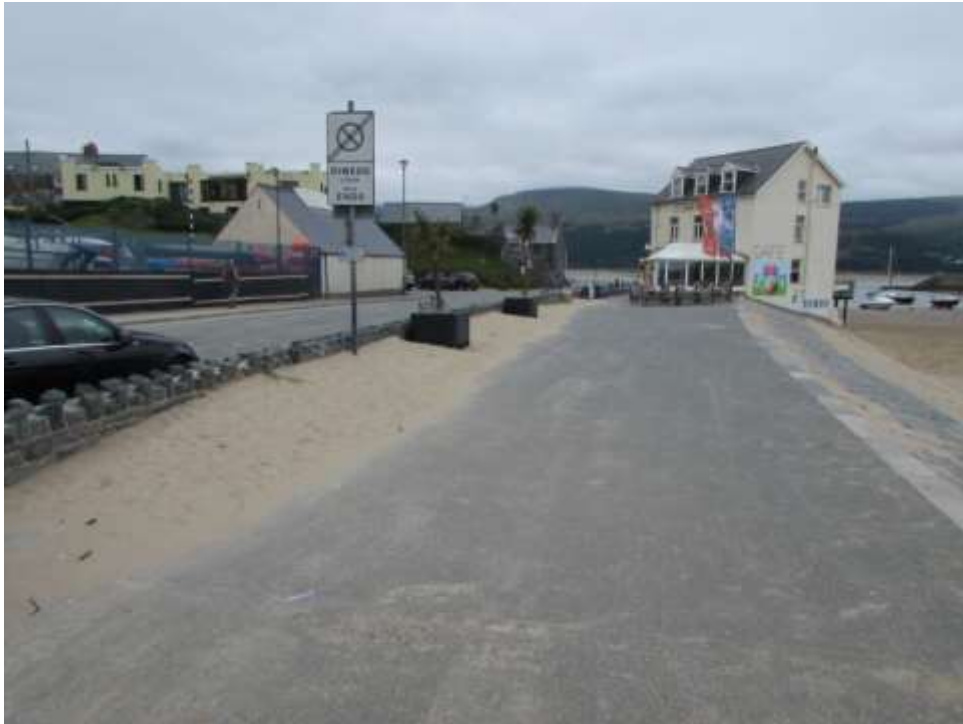
Photograph A1.24. Windblown sand on the promenade by the Bath House Café

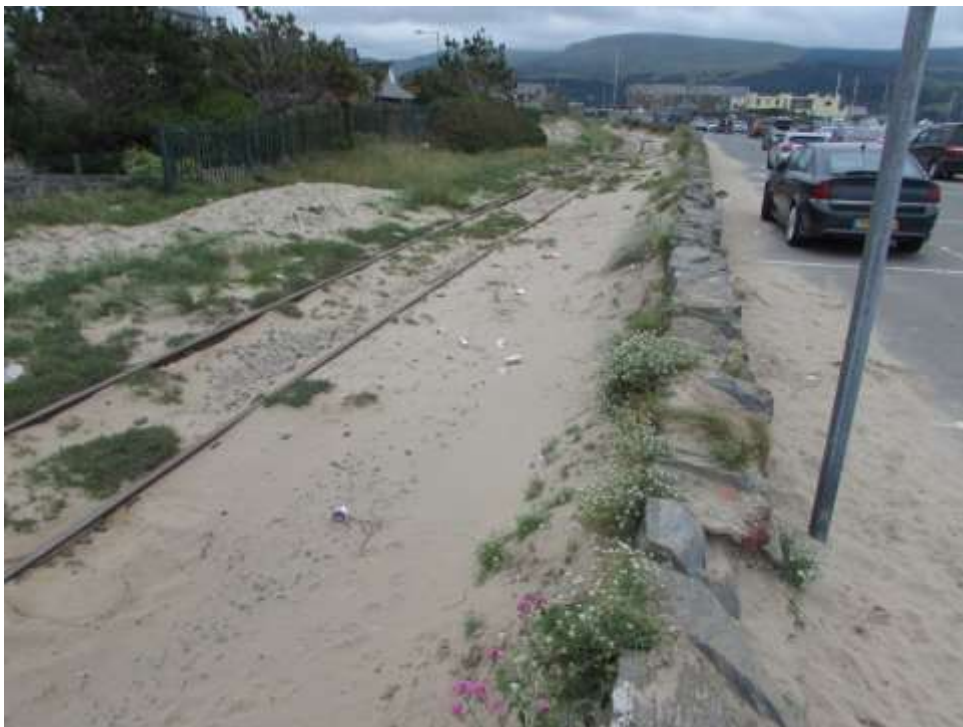
Photograph A1.25. Accumulation of windblown sand on the railway line and against the rear wall of the main beach car park

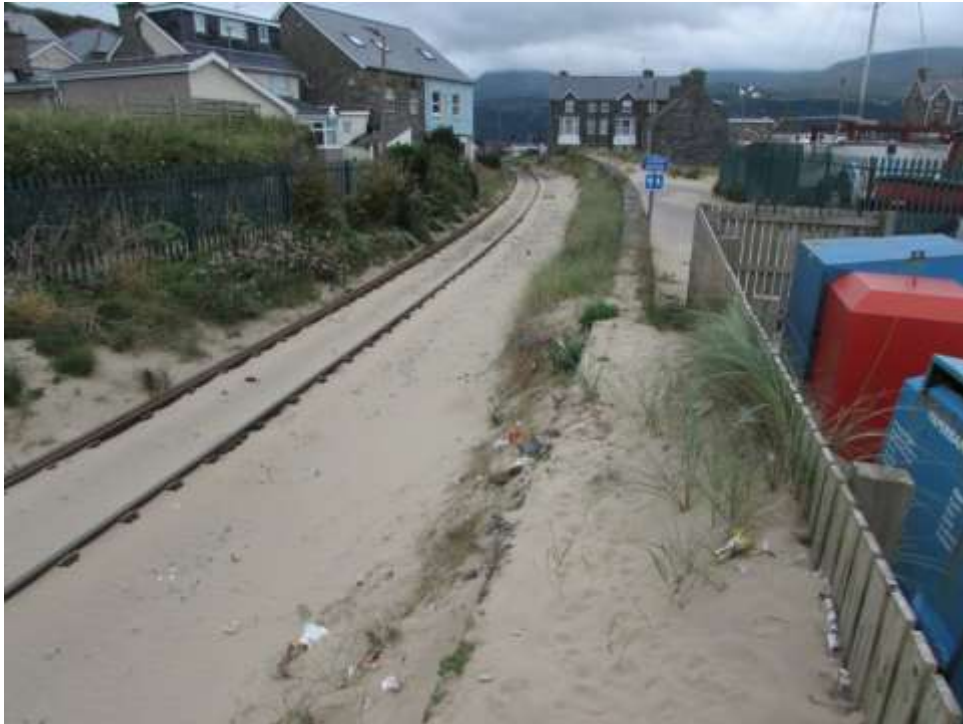
Photograph A1.26. Accumulation of windblown sand on the railway line adjacent to the south east corner of the beach car park; view towards the southeast (Mawddach estuary)

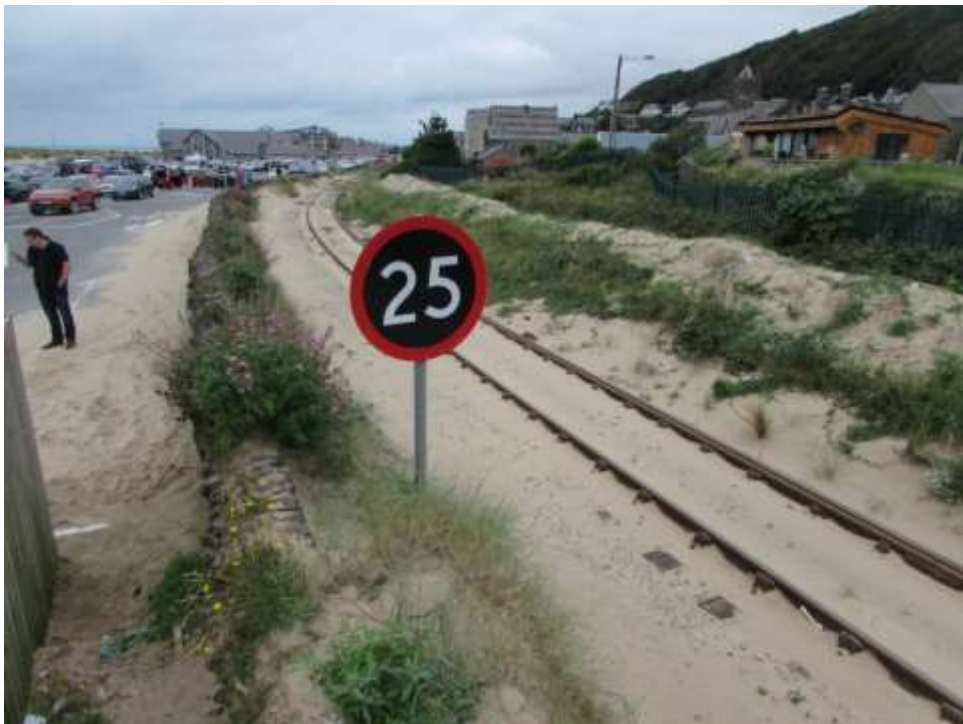
Photograph A1.27. Accumulation of windblown sand on the railway line adjacent to the south east corner of the beach car park; view towards the northwest (Barmouth station)

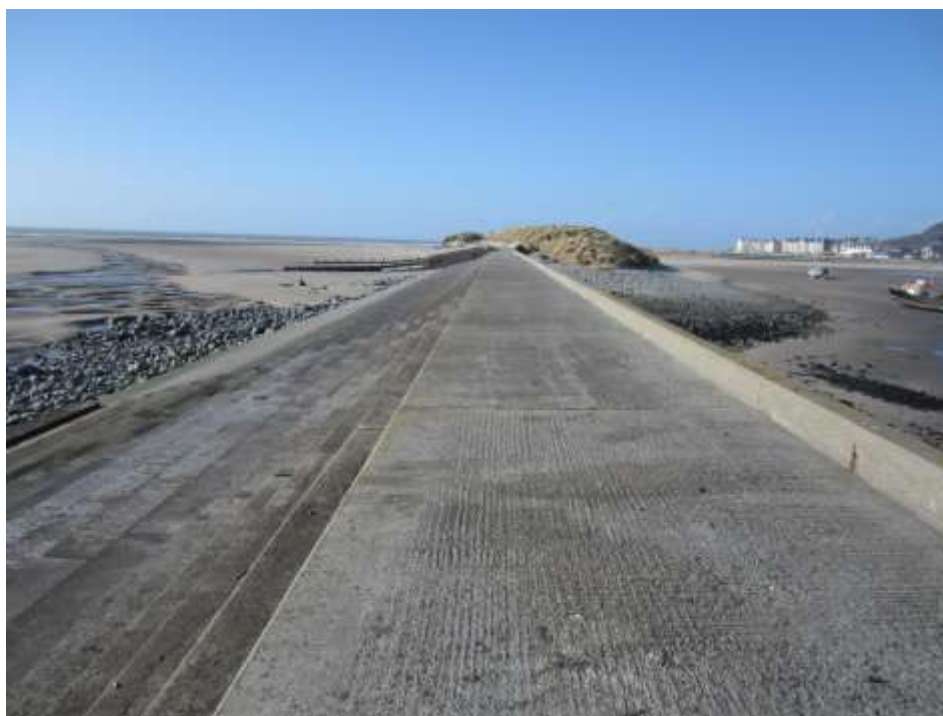
Photograph A2.1. View north along the Trwyn y Graith breakwater, with ‘stripped’ beach to the left, exposing three groynes and the remains of the southern arm of the old rubble breakwater

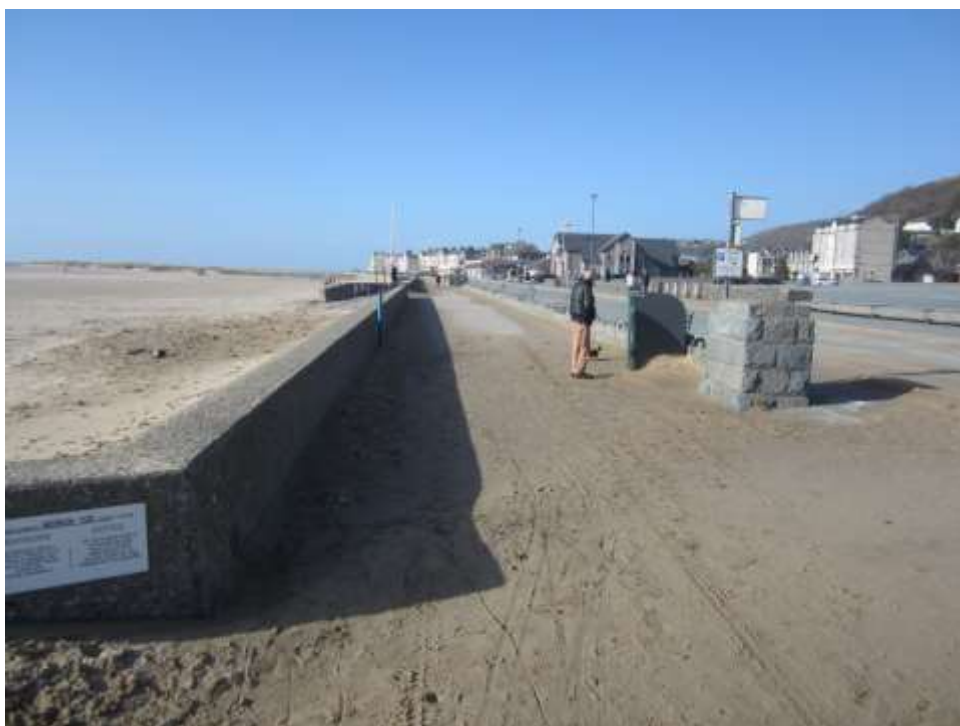
Photograph A2.4. Windblown sand on the promenade and road by the southern beach car park, view looking northwest
