Barmouth Beach Blown Sand Management Options

**Report prepared for
Gwynedd Council**

KPAL Report No: 19100

27 October 2016

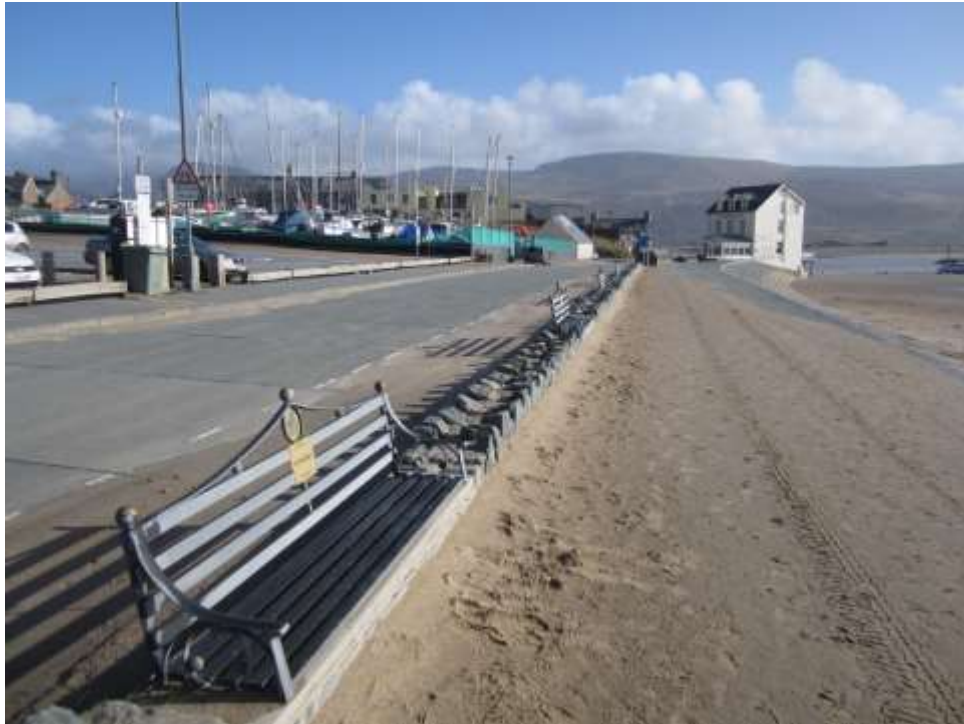
Photograph A2.5. Windblown sand on the promenade and road by the southern beach car park, view looking southeast towards the Bath House Cafe

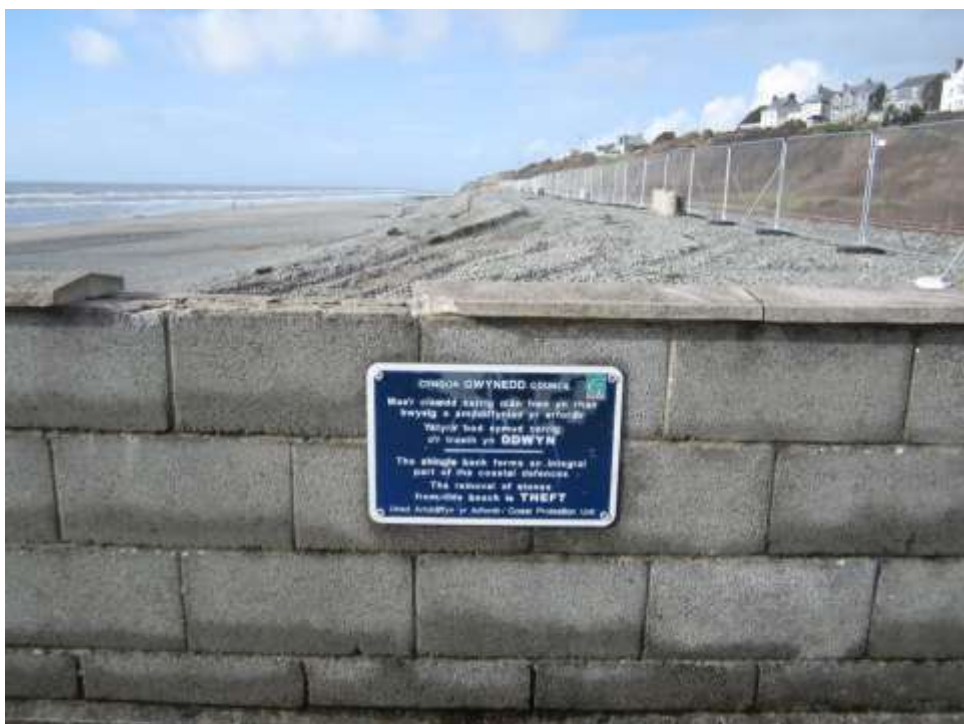
Photograph A2.6. The re-profiled shingle beach immediately adjacent to the car park at the northern end of the promenade; this area and other areas further north were seriously overwashed during the winter of 2013-14, leading to temporary closure of the railway

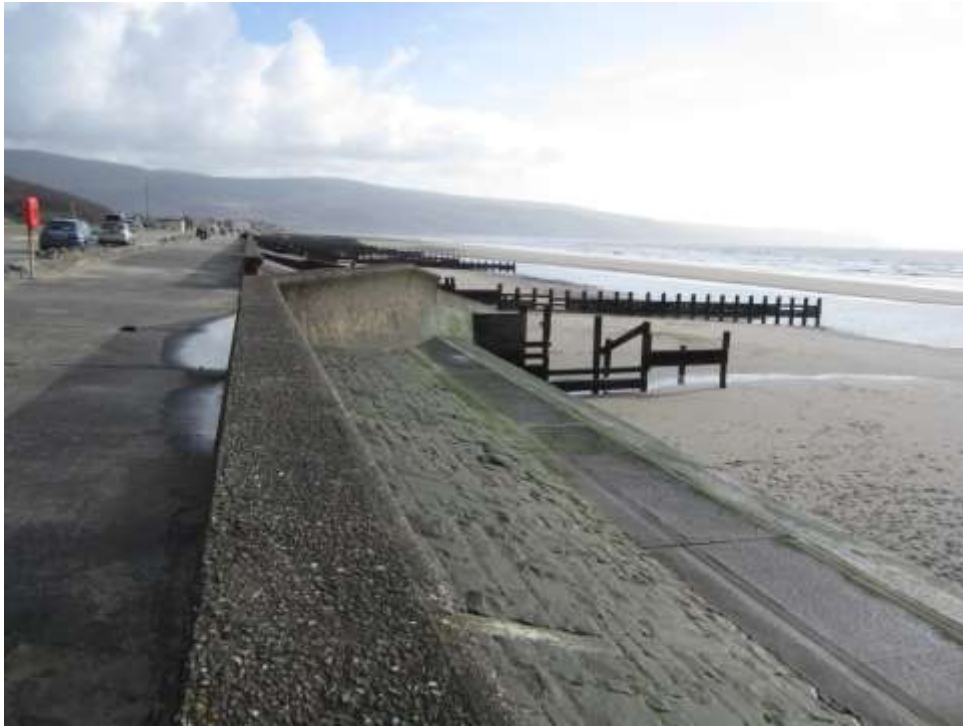
Photograph A2.7. Low beach level exposing groynes along the northern Marine Parade frontage

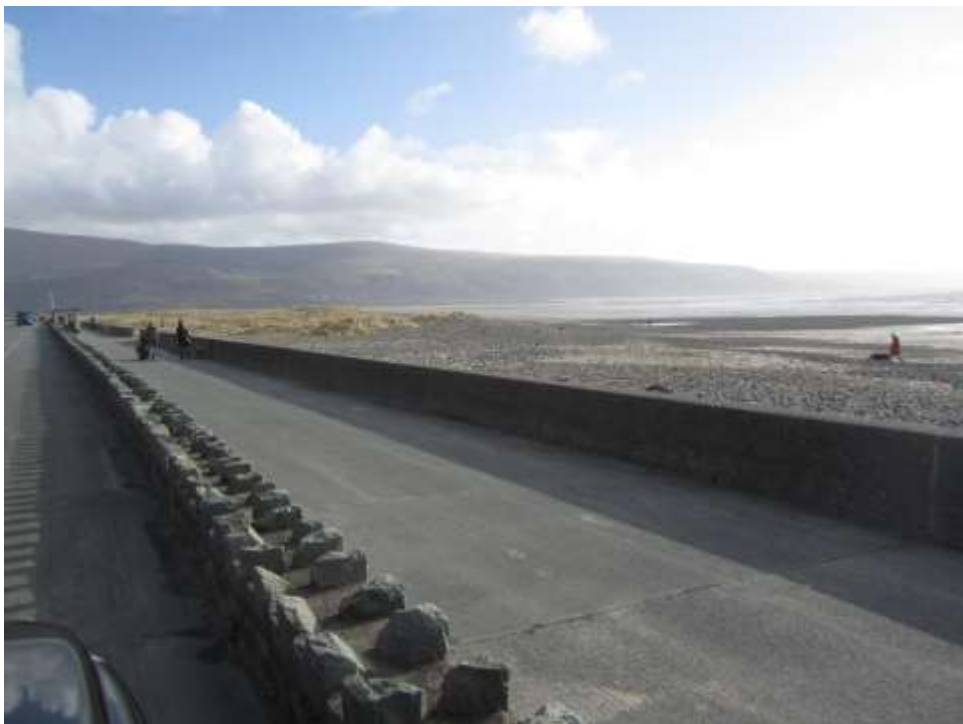
Photograph A2.8. Stable mixed sand and shingle upper beach near the Min y Mor Hotel
